DOLOS-KITI (CYPRUS)

1. GENERAL DESCRIPTION OF THE AREA

The Dolos-Kiti coastal area is located in Larnaka District, at the south coast of Cyprus. The studied area stretches some 36km between Cape Dolos in the west and Cape Kiti in the east.

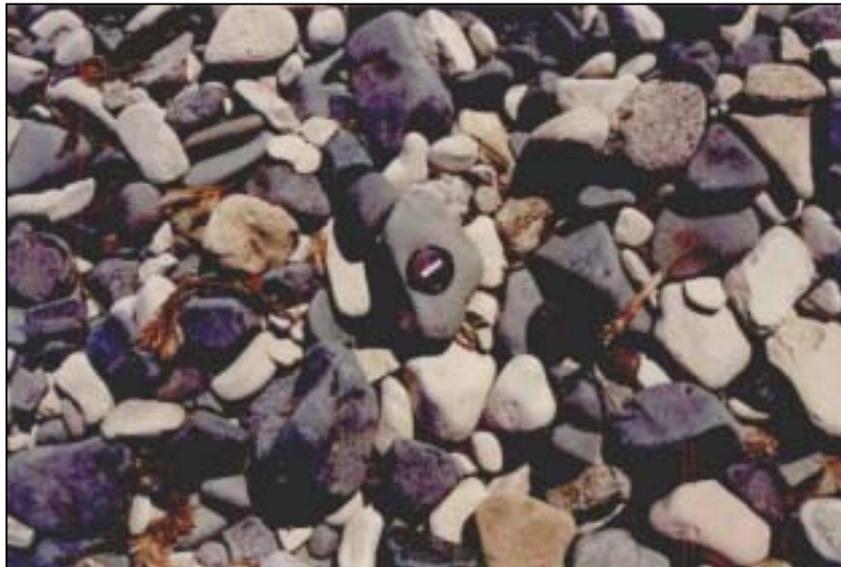
The coastal sediments have a characteristic grey colour (see Figure 2) while the shape of the pebbles and grains range from well rounded to subangular. About 50 % of the grains studied were identified as igneous rocks and 10 % as sedimentary rocks. Bioclastics were also observed (less than 5 %).

Fig. 2: Sediment characteristics of the coastal area of Dolos-Kiti, Cyprus.

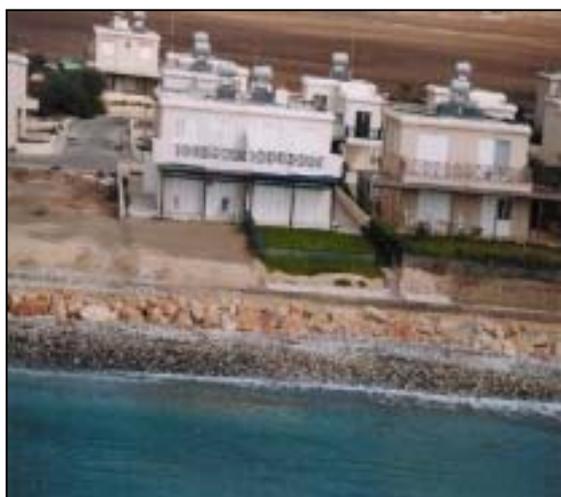
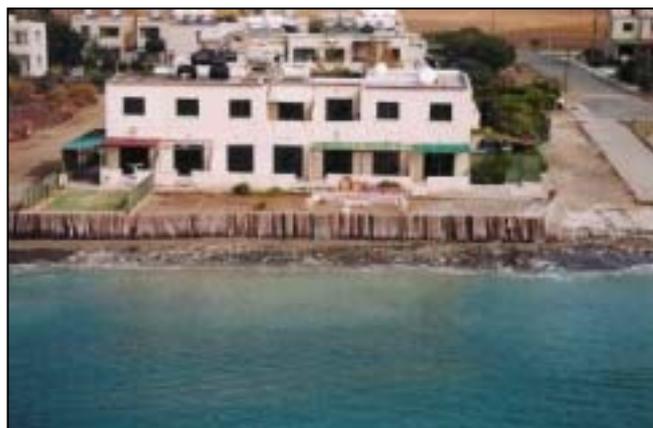
No estimations on the value of endangered properties are available. However, some private properties, like houses, are seriously under threat of erosion (see Figures 3 & 4).

Fig. 3 & 4: Private properties under risk of destruction due to severe erosion. The owners constructed the sea defences illegally (rocky revetments and wooden pile revetments).

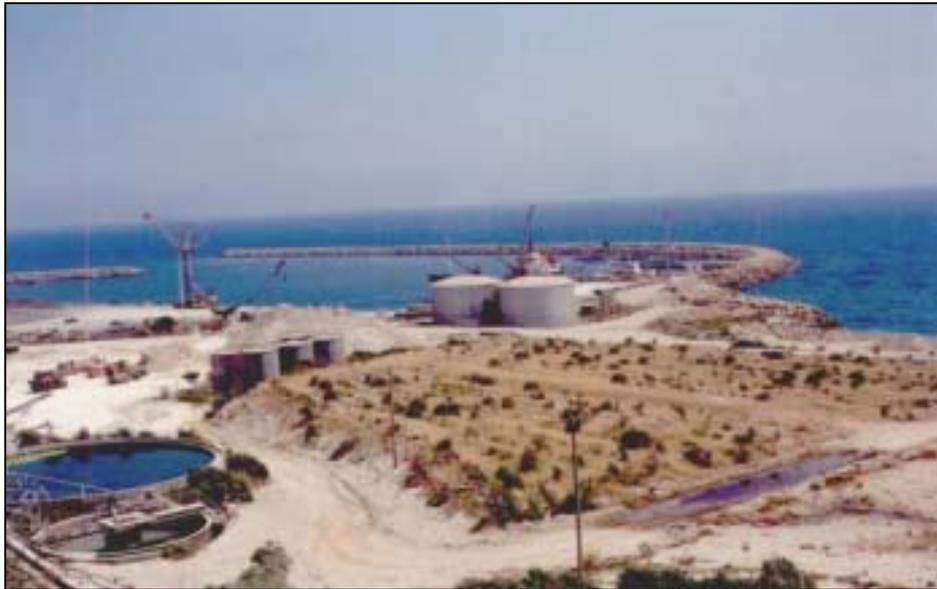
Fig. 5: Cement factory in Vassilikon, with the harbour pier at the end of the photo.

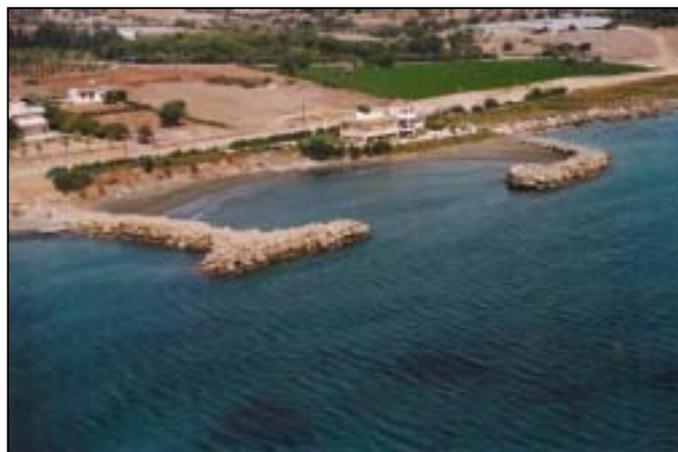
- **Agios Theodoros beach:** the area suffered from severe cliff erosion. In order to protect their constructions, the owners illegally constructed two groins, creating a highly protected pocket beach.

Fig. 6: Groins illegally constructed to protect private property (Agios Teodoros).

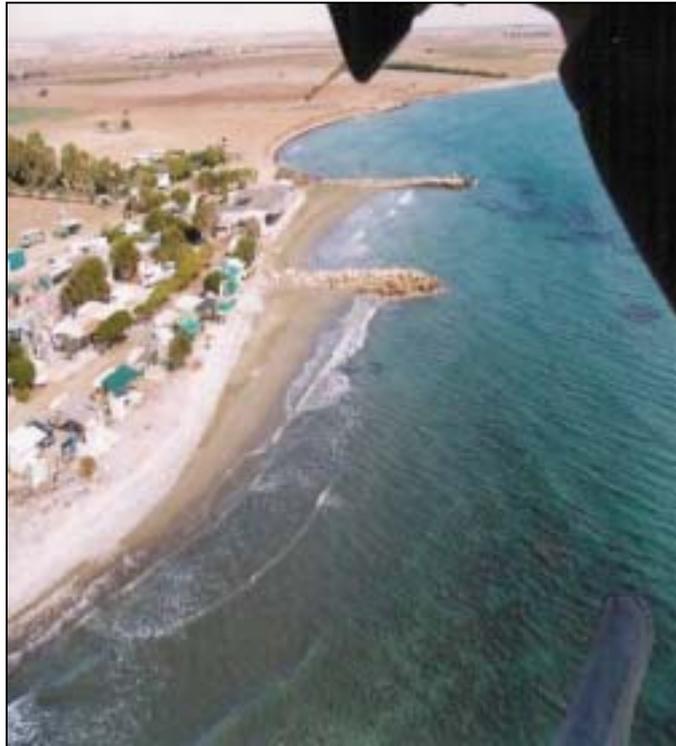
Fig. 7: Groins illegally constructed in Mazotos.

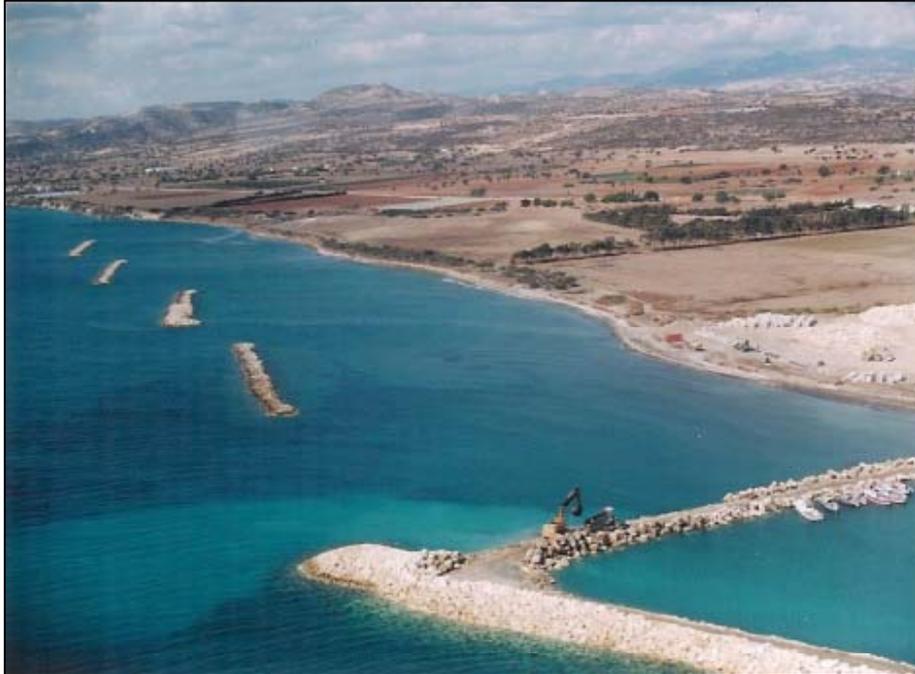
Fig. 9: Offshore breakwaters in Alaminos – view west. An harbour is being illegally constructed at the right bottom of the photo.

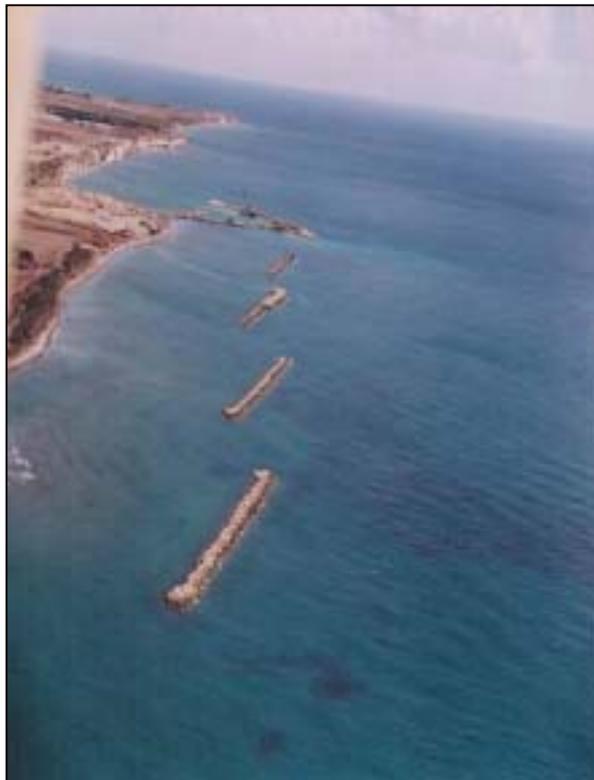
Fig. 10: Offshore breakwaters in Alaminos – view East.
