A coastal conservation programme for the Chennai sea shore, India – A case study

Mani, J.S.

Ocean Engineering Centre, Indian Institute of Technology, Madras, Chennai - 600 036, India;
Fax 0091442352545; Email manijs@hotmail.com

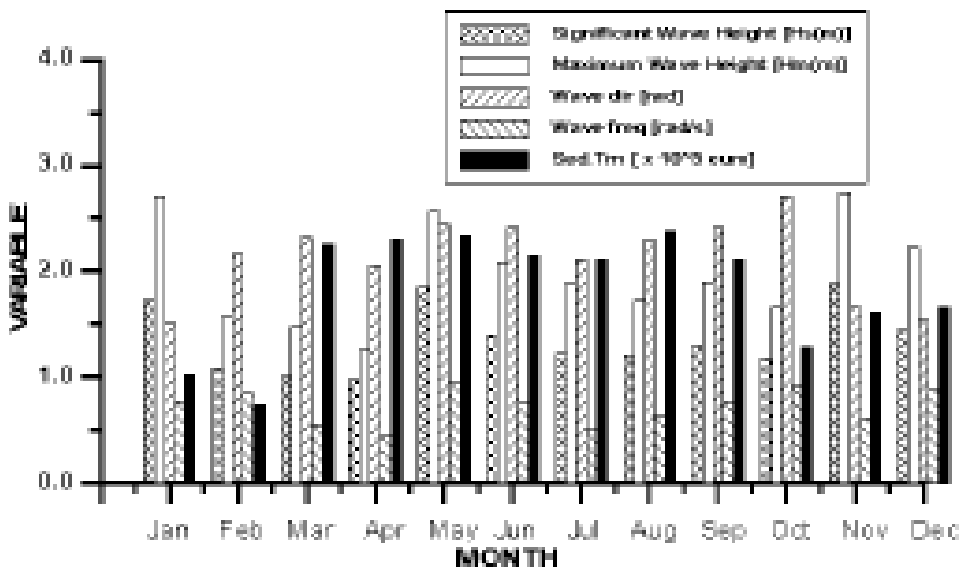
Fig. 2. Wave and sediment characteristics.

Typical monthly wave characteristics given in Fig. 2 indicate a maximum wave height of 2.5 m with a wave period of 6 sec during the southeast monsoon. These values are 3 m and 10 sec, respectively during the north-east monsoon.

A large quantity of sediments is supplied by the major rivers along the east coast and is constantly moved by the waves either towards the north or south depending on the angle of wave approach with respect to the coast. The rate of sediment transport varies from time to time along the coastal region. Analysis presented (Chandramohan et al. 1990) indicates that the transport is towards the north from March to October and towards the south from November to February. The transport rate during March-October varies between 0.5 and 1.5×10^5 m³ per month. During November-February the rate varies from 0.5 to 2.5×10^5 m³ per month. Northerly and southerly components of the annual sediment transport along the Chennai coast are estimated to be in the order of 0.89 and 0.60×10^6 m³, respectively. This results in a net northerly drift of 0.3×10^6 m³ per year. The volume of monthly sediment transport estimated on the basis of suspended load and bed load transport for the coastal region south of Madras harbour is given in Fig. 2.

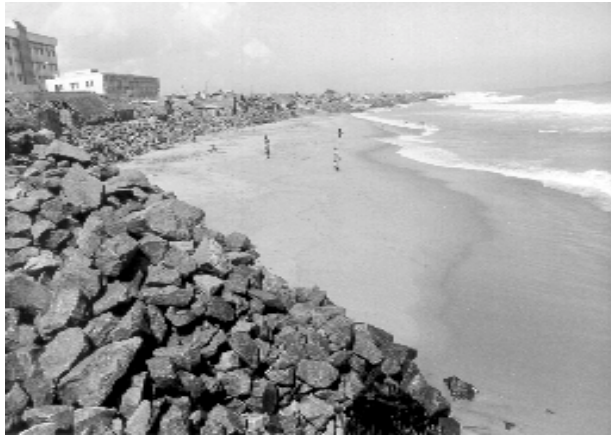
Several consequences of the construction of Madras harbour on the North Chennai coast can be mentioned. *1. Coastal erosion.* The shoreline has receded by about 500 m with respect to the original shoreline in 1876. In order to protect the coastline, authorities resorted to construction of short-term protective structures (Institute of Hydraulics and Hydrology, 1989) from position A to B (Fig. 1). A photo taken in the year 1990 (Fig. 4a) shows the construction of a seawall and a row of huts adjacent to the fishing port. Part of this protected coastal stretch experiences undermining of the sea bed due to large-scale wave action. The erosion along this coast has reached an alarming stage requiring immediate attention. (Kaliasundram et al. 1991). During and after 1990 this stretch of coastline was threatened by severe waves and the authorities resorted to new techniques involving the erection of concrete columns to protect the shoreline near location 'C' (Fig. 4b). At location 'D' a temple existed on a wide beautiful beach until 1990 (Fig. 4c).

Fig. 4. Five pictures of Chennai Beach. **a.** Sea-wall construction prior to 1990. **b.** Erection of concrete pipes (1990). **c.** Temple and wide beach (1990). **d.** Extent of damage to the coast (1994). **e.** Concrete pipes isolated from the beach (1998).

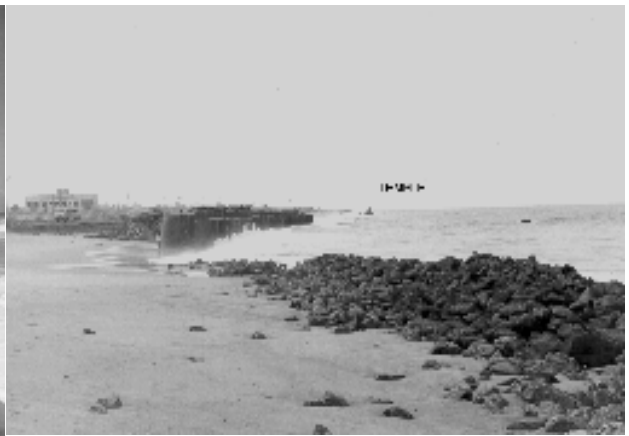
d

The photo in Fig. 4d, taken in 1994, shows the effect of lines of columns on the coastline and the extent of erosion that took place between 1990 and 1994. The severity of coastal erosion is visible from the slow disappearance of the temple. It is estimated that ca. 50 m beach must have been lost during this period. Devastating wave overtopping and severe erosion led to the destruction of the coastal highway and compulsory rehabilitation of fishermen (about 200 families) to safer places. The photo in Fig. 4e, taken in 1998, shows the present situation in which the lines of columns stand

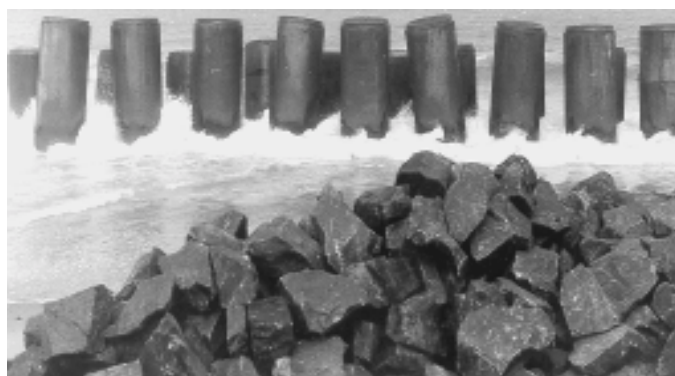
e

isolated from the beach. The temple that existed until 1990 perished due to erosion illustrating the coastline's vulnerability to wave threat. A study reported by Ramaiyan et al. (1997) indicates that the shoreline receded by ca. 100 m between 1978 and 1995.
