Rapid shoreline retreat along the Esmeraldas coast, Ecuador: natural and man-induced processes

Federici, Paolo Roberto¹ & Rodolfi, Giuliano²

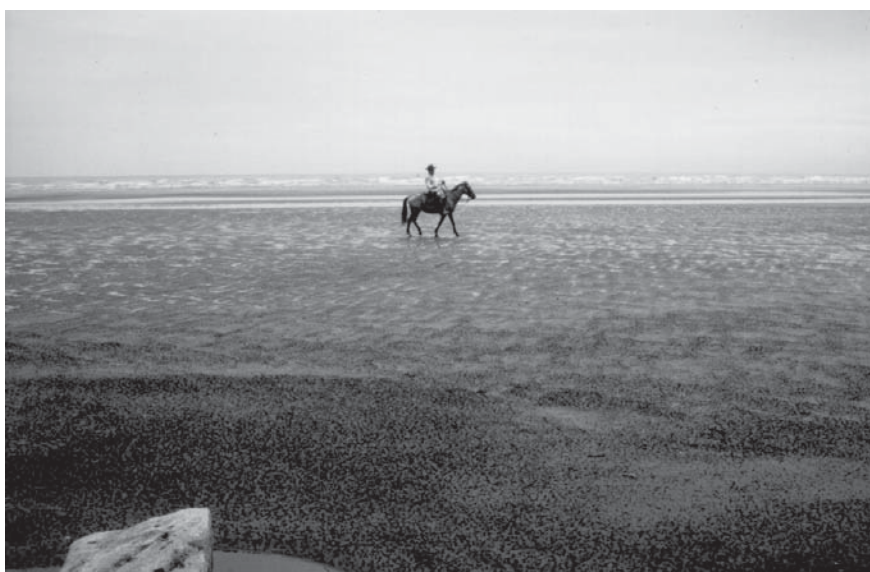
Fig. 2. A stretch of the Pacific shoreline near Camarones during low tide. Due to the low angle of inclination, a wide beach belt emerges. Here, it constitutes the only way for vehicles to reach the villages along the coast after the destruction caused by the last *El Niño* event.

the *El Niño* rainy season. The semi-diurnal tidal streams merge with them, leading to an amplitude which can reach 3 m (Ayon 1987). They alternately cover and uncover wide littoral areas, due to the low angle of inclination of the beaches.

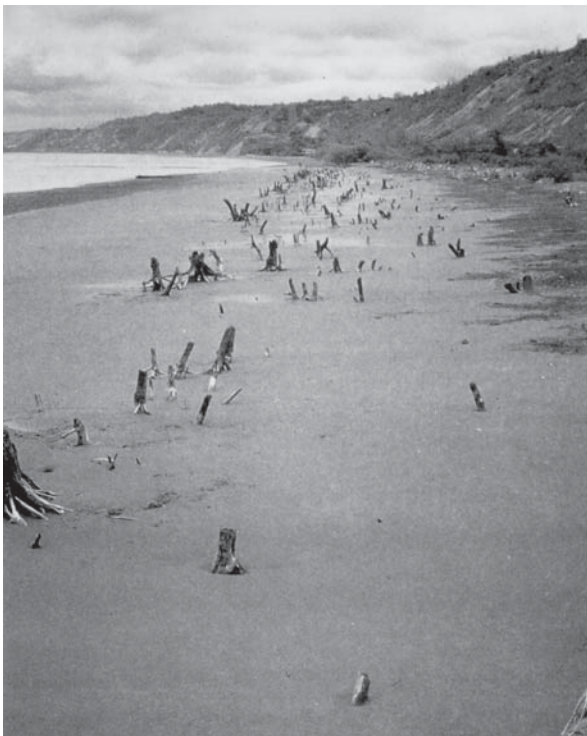
Fig. 3. The Pacific coast few kms north of Camarones, as it appeared in 1992: the *manglares* had been eradicated to install the *camaroneras*.

The installations in Camarones were swept away by the strength of the sea, which in some reaches also demolished the coastal road. Only some remnants of these installations, such as fragments of concrete walls, emerge from the sandy banks during low tides. A comparison of the situation recorded by us in 1989, 1992 and 1999 (Figs. 3 and 4), clearly shows that the mangroves were first eradicate to allow for the installation of the

camaroneras, and that the place where they were installed has subsequently become a bare, muddy, stretch with only some remains of the tanks.

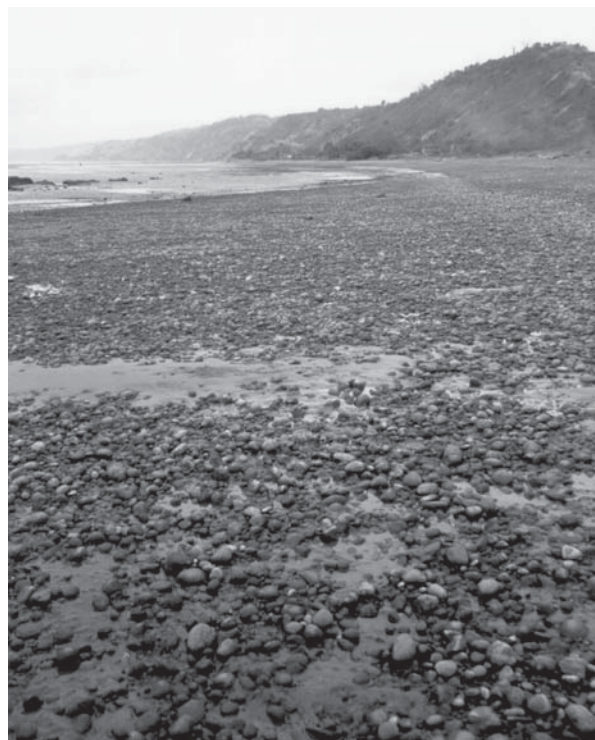
Fig. 4. The same locality as it appears today, after being affected by strong waves during the 1997-1998 *El Niño* event. The *camaroneras* were completely destroyed (see some remnants in the background) and the undermined coastal road has remained interrupted at several points.

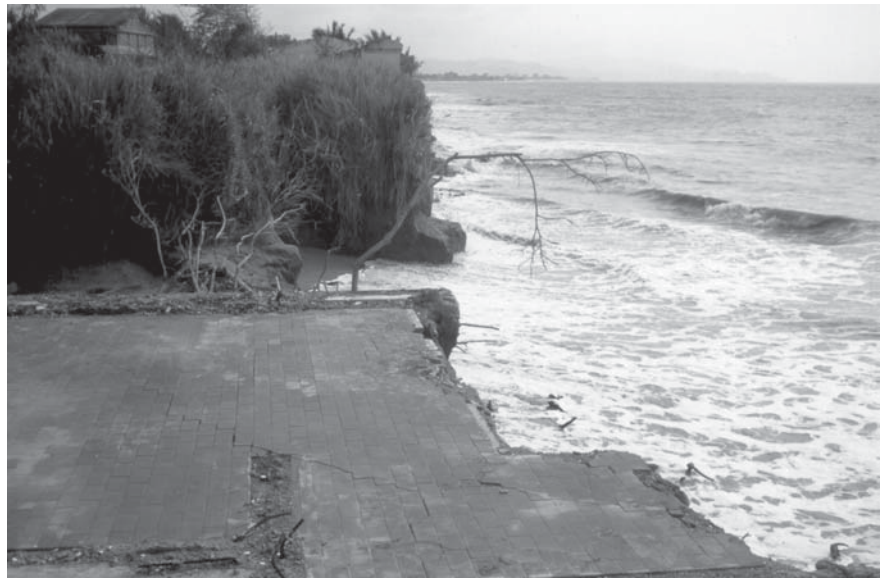
Fig. 5. The rapid retreat of the cliff bordering the Puerto Gaviota surface, due to undermining by waves during high tides, is affecting some cottages built too close to its edge at the time.

Because of its remarkable length of the cliff bordering the Puerto Gaviota surface, the height of which is generally ca. 3 m a.s.l., but 4-5 m at Puerto Gaviota, we have investigated its nature. It is undoubtedly composed of a sedimentary body deposited in a lagoon pond, certainly of continental or transitional environments (sediments contain pulmonate gastropods), the thickness of which is unknown, because its base is located under the present-day sea level. The texture of the sediments, very poorly cemented and rich in calcium carbonate, is prevalently silty.

The rapidity of the cliff edge retreat, ca. 1 m per year, was evaluated on the basis of some surveys carried out directly on the site in two different time-lapse periods (three years: 1989-1992; seven years: 1992-1999), using as a reference both the national topographic map, scale 1 : 25 000, and the aerial photographs taken in different periods by the Ecuadorian Military Geographical Institute in Quito. We should like to acknowledge the latter for the assistance provided. In fact, within the context of the Puerto Gaviota building plan (in 1977), the maps show a road running parallel to the cliff edge, as well as some cottages close to it. These had already disappeared at the time of the first survey (1989). Since 1992 the undermining of the cliff has provoked the edge retreat, affecting other houses (Fig. 5) and dangerously approaching the

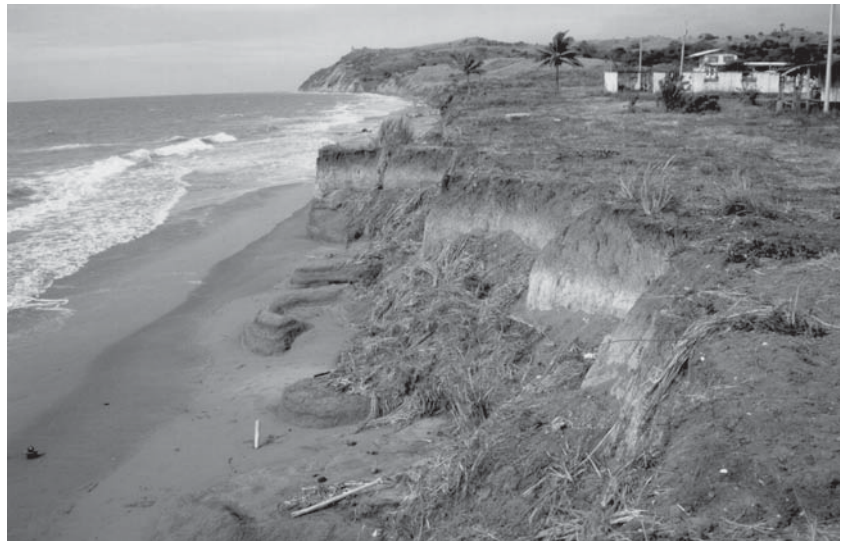
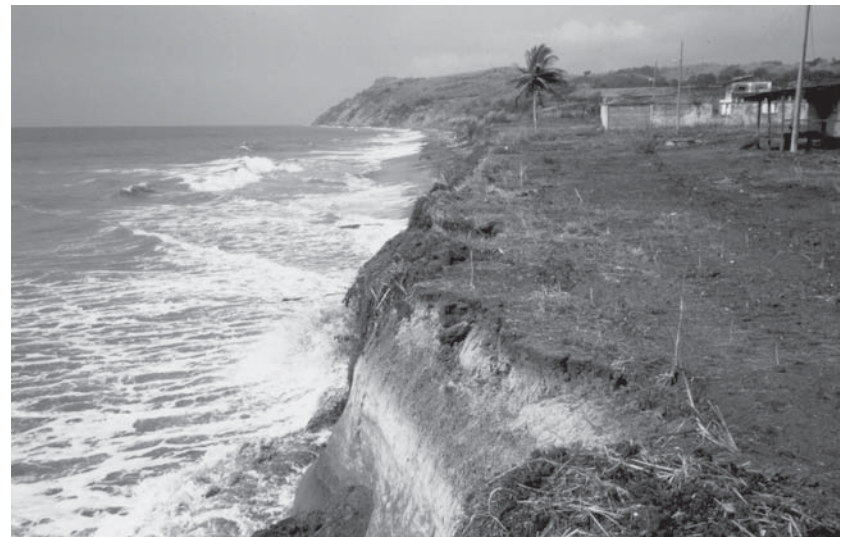
Figs. 6 and 7. These pictures of the northern coastal stretch of the Puerto Gaviota surface (Chevele hilltop in the background) were taken in 1992 (Fig. 6) and in 1999 (Fig. 7). Taking the two palm trees as a reference, one can evaluate the rate of the cliff retreat.

The dominant morphogenetic process in the Atacames bay, in particular in the northern sector from Tonsupa to Chevele, is undoubtedly the rapid erosion of the shoreline, due to wave motion. Even during the ordinary high tide phase it undermines the cliff, the base of which, as mentioned above, is constituted by weak silty sediments, provoking its progressive fall and retreat. The failures which have affected the settlements built along the coast bear witness to the gravity of this process. The terraced surface of Puerto Gaviota-Tonsupa was probably much more extensive in the past than it is today, as one can infer from its imaginary continuation seawards, following the same inclination. Considerable, continuous erosive phenomena have progressively

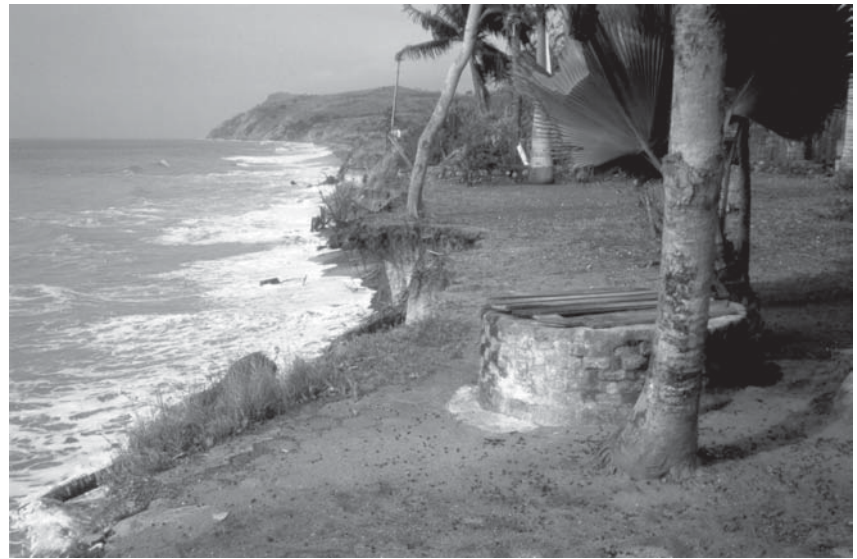
Fig. 8. A water well, dug some tens of metres inland at the time, is now close to the cliff edge.

camaroneras of Puerto Gaviota, as well as demolishing the high cliffs of the Chevele hills. Up till 1999 the increases in retreat were spectacular. The seaward front of such a tank at Puerto Gaviota is now directly on the seashore and the water pipes have become obsolete; the fishermen's huts, once quite far from the cliff edge, now overhang the beach (Figs. 6 and 7) and other cottages, along the same line, are almost completely destroyed. In particular, there is a remarkable remnant of a water well, with its higher part overhanging the beach, while its base is undermined by swash (Fig. 8). The beautiful seafront terrace of one of the best hotels, with a double row of palms planted at the time of the Puerto Gaviota building plan, has been cut seawards. The staircase carved on the cliff has been destroyed, so that it is now difficult to get down to the beach.
