Erosion risk levels at the NW Portuguese coast: The Douro mouth - Cape Mondego stretch

Veloso-Gomes, F.^{1*}; Taveira-Pinto, F.^{1,2}; das Neves, Luciana^{1,3};
Pais Barbosa, Joaquim^{1,4} & Coelho, Carlos⁵

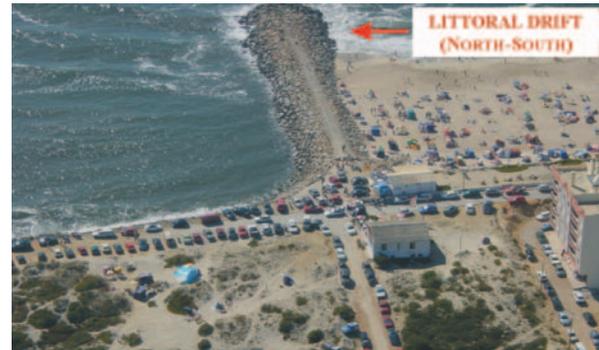
Fig. 2. Groyne effect; updrift accretion on Vagueira beach (source: CCDR-Centro; Anon. 2001).

The dominant direction of the littoral drift can be directly shown by the sediment accretion to the North updrift of obstacles (e.g. groynes) and by the erosion to

the southern downdrift (Fig. 2). Indirectly, this can also be demonstrated through the analysis of the wave direction frequencies reaching the Portuguese West coast, which exhibits the higher frequencies and intensities in the north/west quadrant.

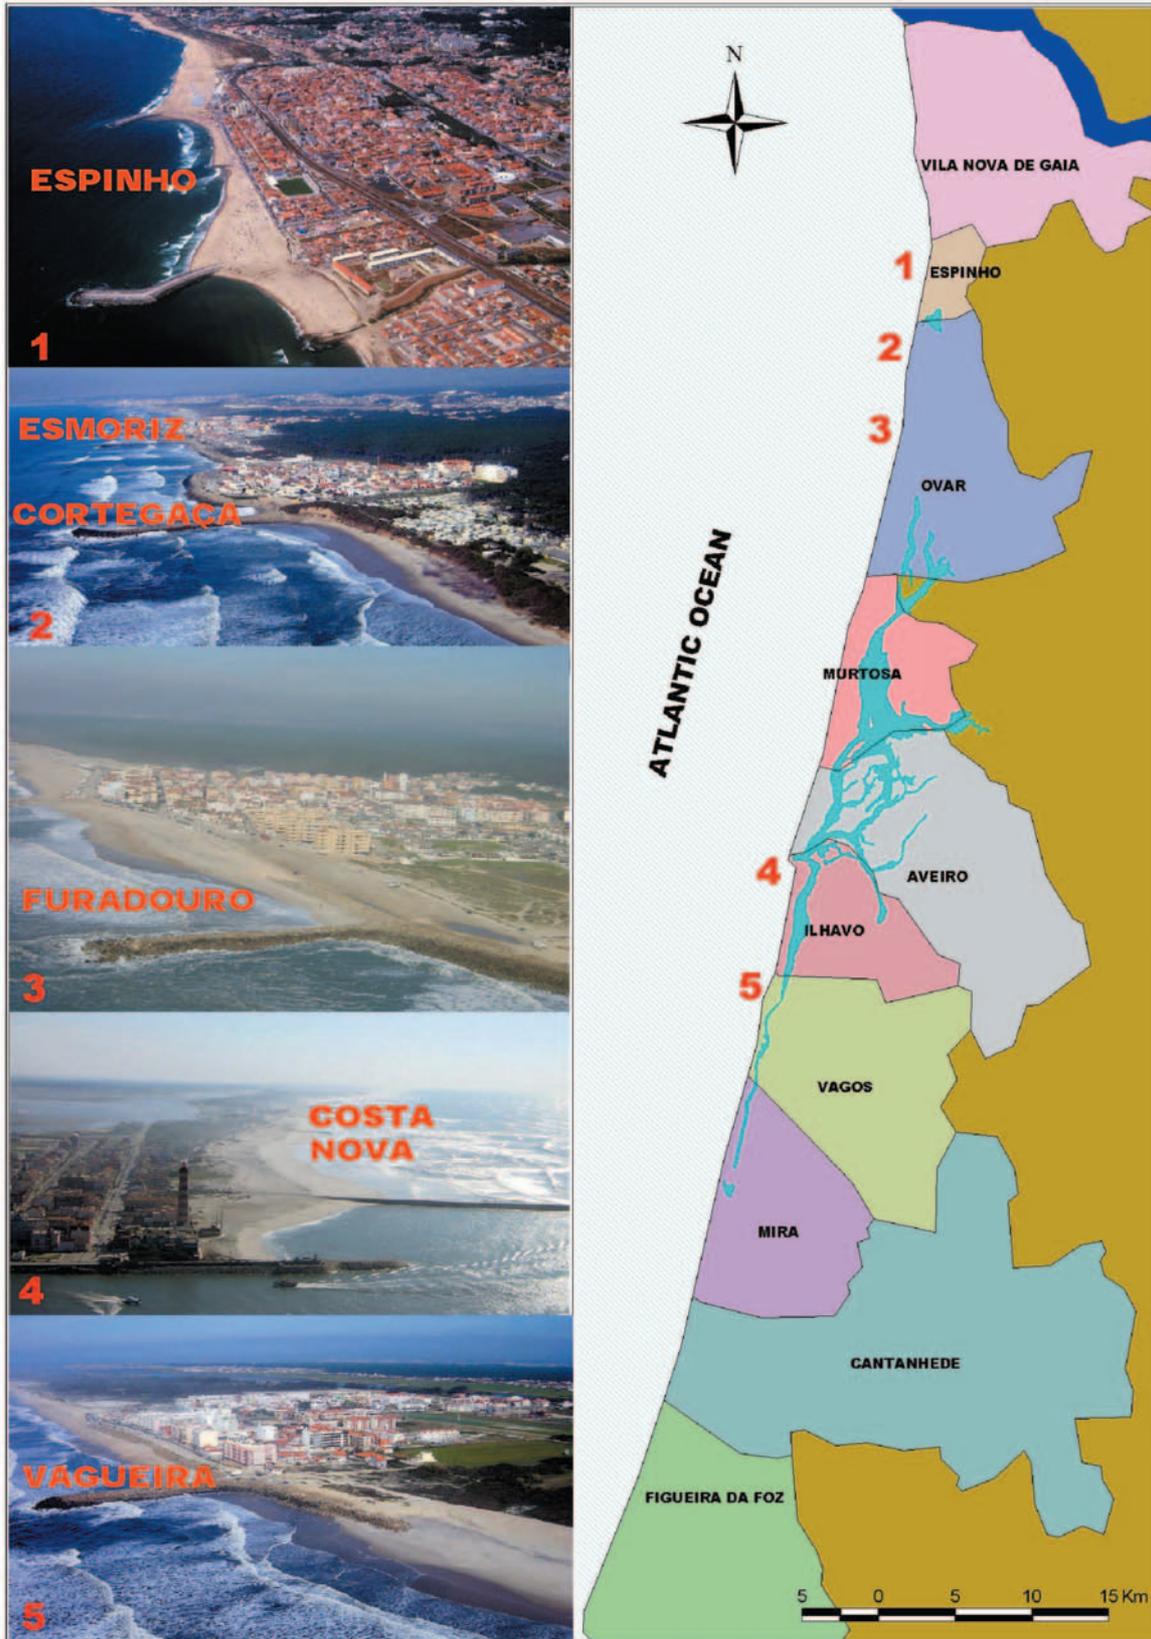
Fig. 3. Examples of coastal segments facing coastal hazards.

Several coastal populations are facing high risk situations, for instance at Cortegaça, Vagueira and Espinho (Fig. 3). Indeed, despite the existence of coastal defences the situation continues to be critical. Lessons learnt from the past show that most of the measures taken so far to prevent erosion provide only local solutions which do not address the underlying cause of erosion, i.e. shortage of sediment supply. In fact, in some cases, erosion is accelerated downdrift of the protected areas.

The shoreline between Esmoriz and Cortegaça has retreated as far as the established urban seafront line of defence and further retreat will implicate loss of the houses built behind those defences. Currently, the two cities appear as small capes protruding from the natural coastline, with the houses on their top being almost directly exposed to sea attack (Fig. 3 – photo 2).

Segment 7, Barra/Vagueira, ca. 9 km long, extends from the southern breakwater of Aveiro harbour to the northern groyne of Vagueira (Fig. 3 – photo 4). It is strongly influenced by the measures taken in the harbour, especially dredging. Additionally, in contrast to the previous segment, it suffers from sediment trapping at the updrift side of the breakwaters of Aveiro. This segment has one of the highest erosion rates in the study area. Indeed, in the period between 1947 and 1978 an estimated 200 to 300 m of shore was eroded away (Anon. 1998). This high rate of erosion led to the construction of the first groyne field in 1972. Until 1996, erosion progressed over more than 100 m away from the influence zone of the groyne (Anon. 2003). Currently, groynes, seawalls and artificial dunes protect the shoreline, but erosion is still ongoing.

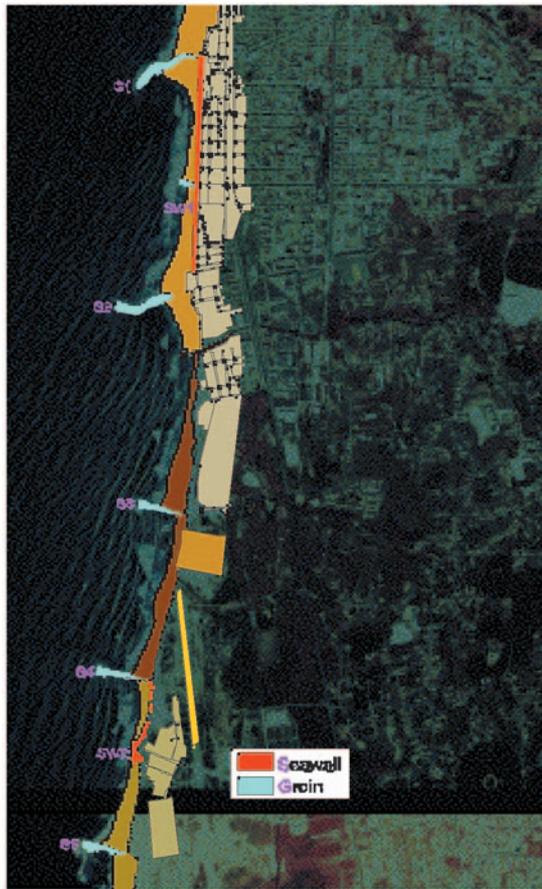
Fig. 4. Coastal structures between Espinho and Paramos (Pais Barbosa 2003).

Espinho – Paramos, ca. 5 km length (Fig. 4)

- Groin 1 – Espinho (1918 / 1981/1983; 350 m)
- Groin 2 – Espinho (1981/1983; 400 m)
- Seawall (400 m)
- Groin 3 – Espinho (1981/1983; 300 m)
- Groin 4 – Paramos (1981/1983; 280 m)
- Seawall (100 m)
- Groin 5 – Paramos (1985; 280 m)

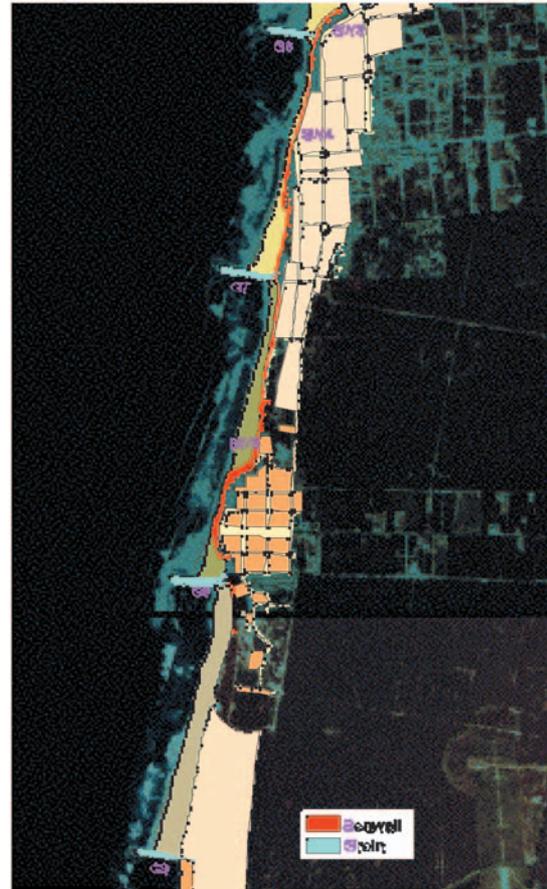
Fig. 5. Coastal structures between Esmoriz and Cortegaça (Pais Barbosa 2003).

Esmoriz – Furadouro (~11 km length, Figs. 5 and 6)

- Seawall (1978; 140 m)
- Groin 1 – Esmoriz North (1987; 160 m)
- Seawall (before 1977 / 1985; 850 m)
- Groin 2 – Esmoriz South (1987; 180 m)
- Seawall (1990; 1000 m)
- Groin 3 – Cortegaça (before 1972 / 1982; 170 m)
- Groin 4 – Maceda (1989; 150 m)
- Groin 5 – Furadouro North (1986; 100 m)
- Seawall (before 1959 / 1970/ 1984; 300 m)
- Groin 6 – Furadouro South (1981; 1997)
- Seawall (1982; 300 m)

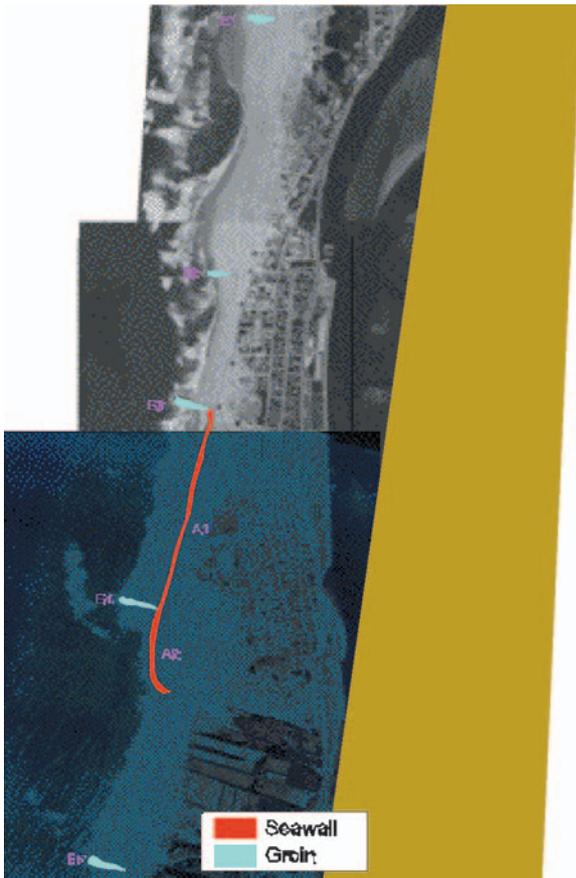
Fig. 7. Coastal structures between Barra and Costa Nova (Pais Barbosa 2003).

Barra – Costa Nova – Vagueira, (~10 km length, Figs. 7 and 8)

- Groin 1 – Barra (1972; 120 m)
- Groin 2 – Costa Nova (1972; 120 m)
- Groin 3 – Costa Nova (1972; 120 m)
- Seawall (before 1981; 750 m)
- Groin 4 – Costa Nova (1972; 120 m)
- Seawall (before 1981; 300 m)
- Groin 5 – Costa Nova (1979; 100 m)
- Groin 6 – Vagueira (before 1984; 130 m)
- Seawall (before 1984; 800 m)
- Groin 7 – Vagueira

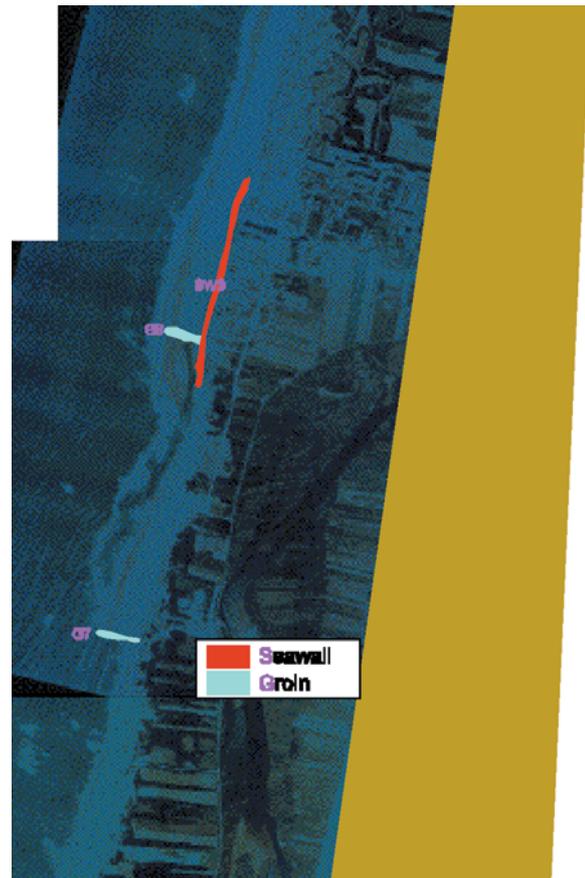
Fig. 8. Coastal structures between Costa Nova and Vagueira (Pais Barbosa 2003).

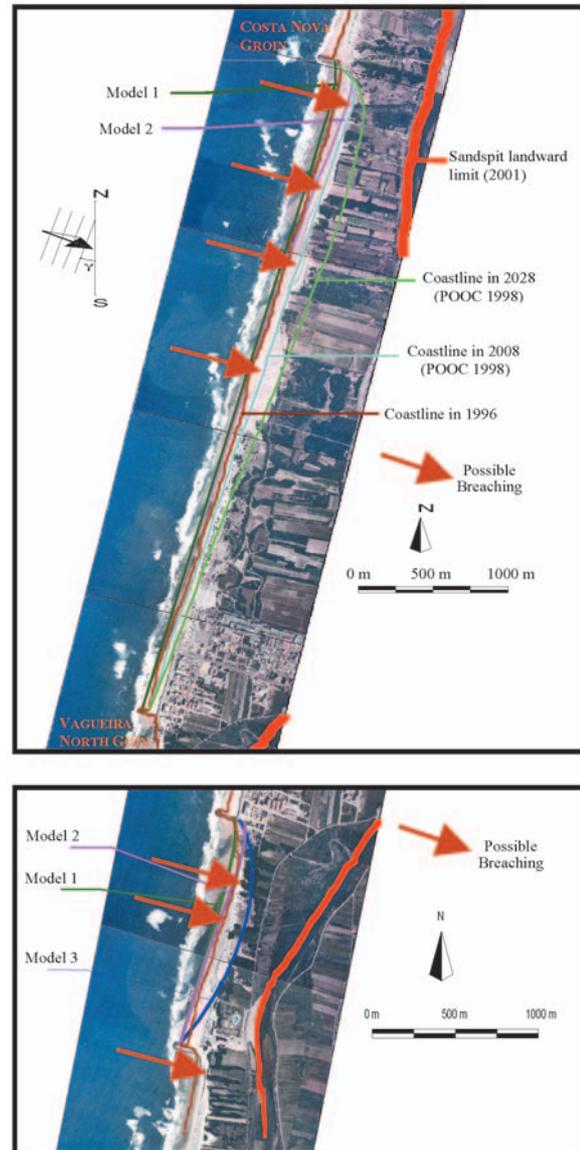
Fig. 9. Sand spit configuration and possible trends near Vagueira. Theoretical forecast of possible breaching of new inlets – Carlos Coelho (2001) in Pais Barbosa (2003), based on the aerial survey in Anon. (2001).

1. The shoreline development trends for the next 10 to 30 years presented in 1998 in the POOC (Fig. 9), are possibly very optimistic, since the actual situation shows that the predicted development (according to several models) is about to be reached. Current trends are particularly concerned with inlet breaching (Fig. 9), establishing new connections between the sea and the lagoon. As mentioned above, one of the most critical areas in this coastal segment is the dune system of South Costa Nova/South Vagueira. The existing threats were considered within the POOC, which proposed an intervention consisting of the construction of a retreated dune system, but there are still some important issues to be fulfilled.
