The use of sand by-passing systems in the management of an urban beach. The case of Capbreton, France.

Authors: Vincent Mazeiraud and Nicolas Garcia

SOGREAH Maritime,
6, rue de Lorraine, F-38130 Echirolles, France.
Email: vincent.mazeiraud@sogreah.fr
Email: nicolas.garcia@sogreah.fr

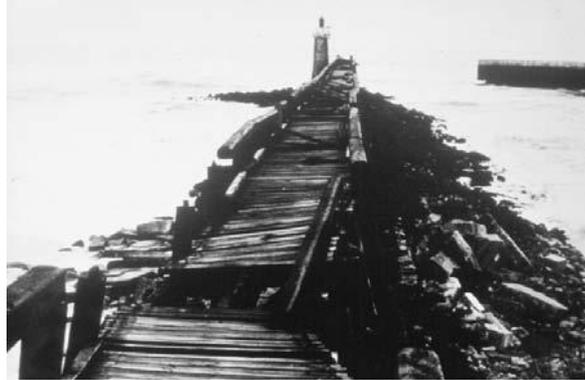
Figure 4: Storm of winter 1978/1979 -Destruction of the last 25 metres of the Northern jetty and landing stage

The storm of winter 1978-1979 destroyed the last 25 metres of the Northern jetty (fig 4) and badly damaged the seafront structures, which had to be reinforced in 1981². However, no repairs were made to the Northern jetty, which today remains as it was left after the storm. Further longitudinal protection was built in 1981 opposite the CERS (Centre Européen de Rééducation Sportive) and since then has been regularly consolidated with rockfill.

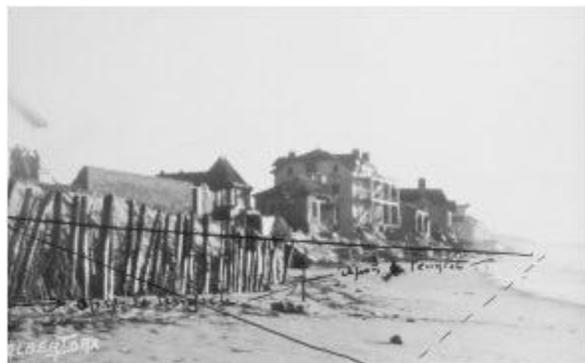
Figure 5: Buildings damaged by the 1938 storm.

Coastal erosion phenomena at Capbreton began long before the extension of the Northern jetty in 1974. In 1938, houses along the seafront were threatened with collapse (fig 5). In 1952 and 1954, winter storms caused significant damage to the installations on the upper beach (fig 6).

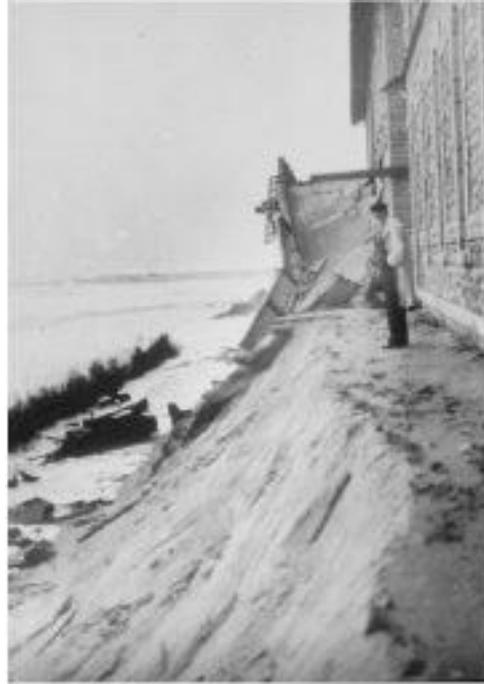
Figure 6: 1954 storm. Collapse of the Préventorium

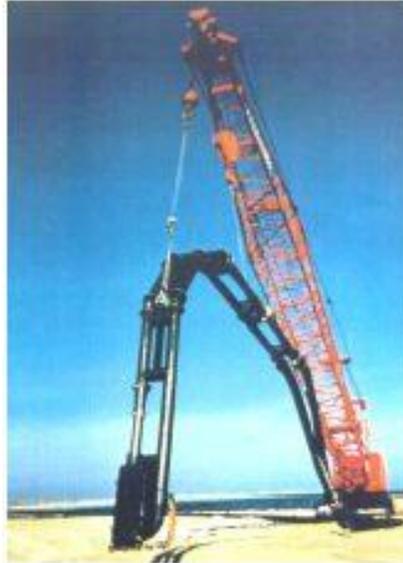
Figure 8: Indian River hydro-ejector, Delaware, USA

- a hydro-ejector that will be used to extract the sand from Notre-Dame beach (fig 8),*
- a pump for taking clear water from the Boucarot channel, connected to the hydro-ejector,*
- relay pumps placed to the rear to provide sufficient hydraulic power to supply the southern beaches (Savane, bunker),*
- delivery pipes laid across the Boucarot channel,*
- rigid pipes laid below the seafront at Capbreton with regularly spaced outlets,*
- flexible pipes that can be connected to the outlets.*
