## ZEEBRUGGE – KNOKKE HEIST (BELGIUM)

## 1. GENERAL DESCRIPTION OF THE AREA

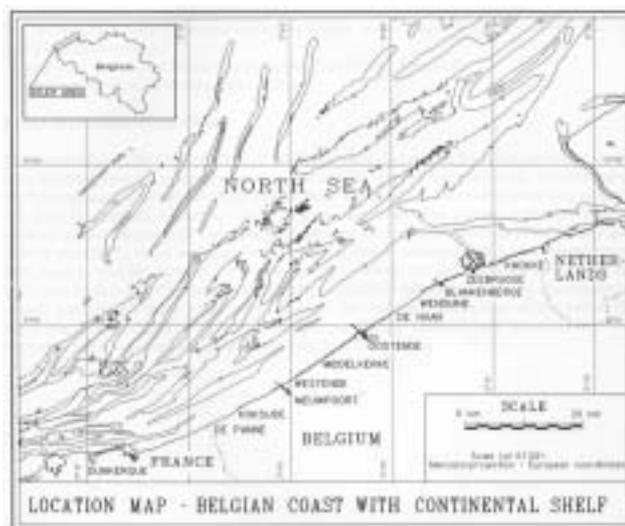
Fig. 2: Overview of Belgian Coast.

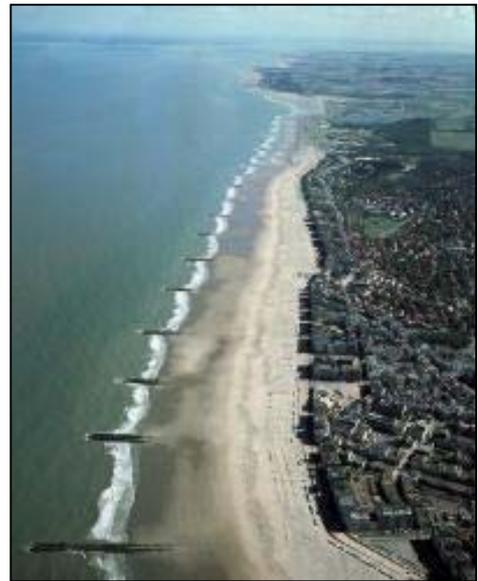
*Fig. 5: Groins at Knokke-Heist.*

At that time there rather narrow beaches had already developed due to the harbour breakwaters intersecting the longshore transport. Notwithstanding the protection provided by the groins, erosion of the beaches continued; the Appelzak tidal gully already played an important role in the erosion process. At high tide the beach disappeared, leaving the seawall exposed to attack by storms.

The winter storm of 1976 left a seriously eroded 9 km long beach in front of the seawall and groins field of the Knokke-Heist municipality. Storm waves damaged the seawall on several occasions so that coastal protection works became very urgent.

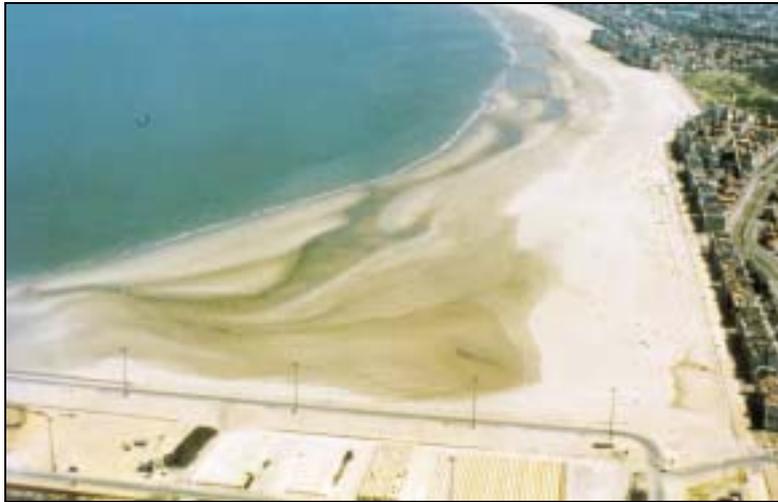
*Fig. 9: Nourishment directly downstream of harbour breakwater.*
