WESTERN COAST OF JUTLAND (DENMARK)

1. GENERAL DESCRIPTION OF THE AREA

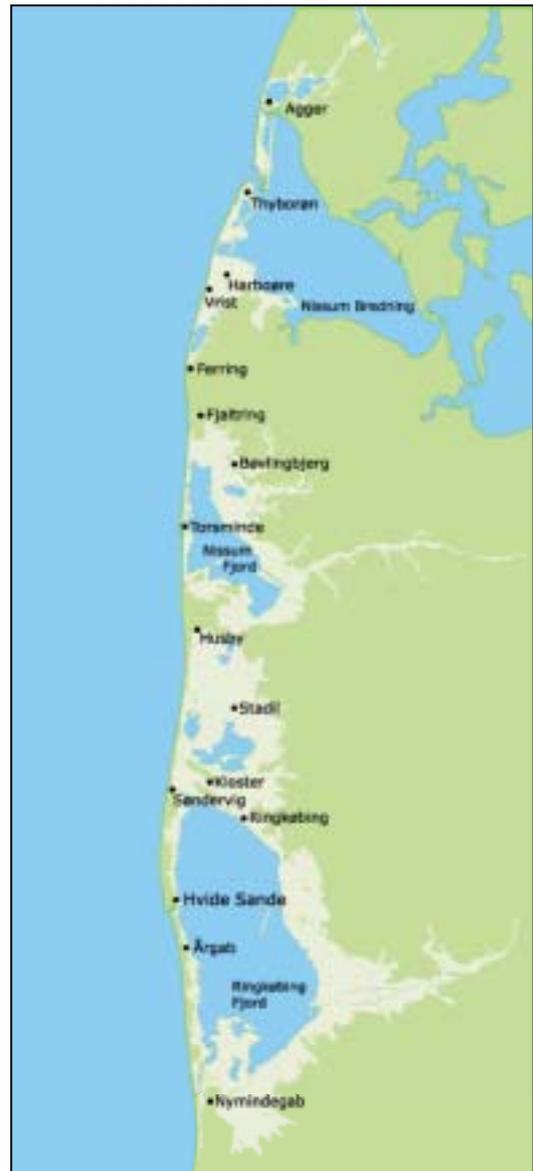
Fig. 2: West coast of Jutland.

In Figure 2, three big fjords can be seen in the case area:

➤ **Ringkøbing Fjord- Hvide Sande**

The most southern bay is the Ringkøbing Fjord. It is Denmark's largest enclosed fjord with an outlet to the North Sea at the lock in Hvide Sande. The fjord is 40 km long and 10 km wide.

➤ **Nissum Fjord- Torsminde**

North of Ringkøbing fjord, the Nissum fjord is located with a surface of 70 km². It is a shallow fjord area with shoals and sandbanks and with intertidal zones and salt marshes with brackish lagoons, meadows and reedbeds. The fjord is connected with the North Sea by sluices at the small town of Torsminde.

➤ **Nissum Bay- Thyboron (channel).**

Nissum Bay is the largest of the three bays, it is connected to the North Sea with the Thyboron Channel.

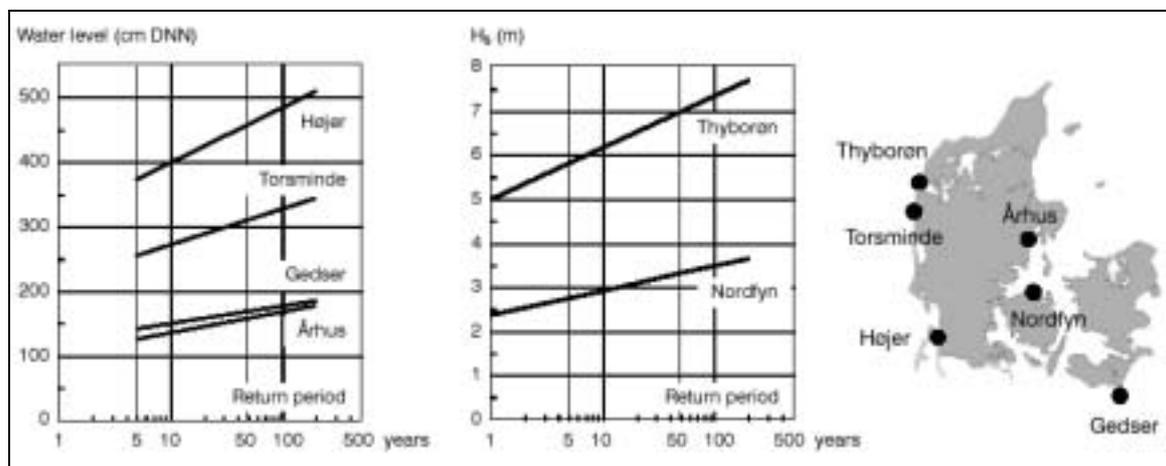
Fig. 3: Comparison water levels and wave heights at Danish coast.

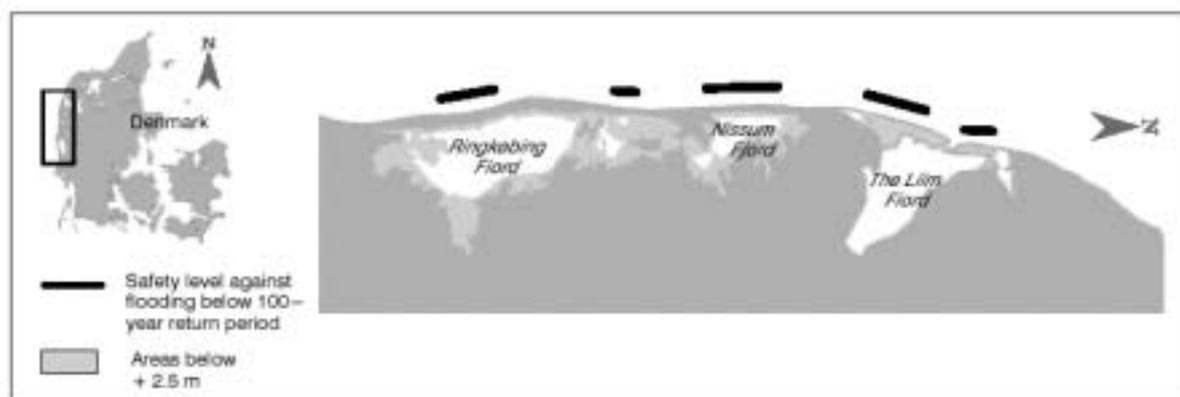
Fig. 4: Weak locations along the case area in 1982.

Average erosion of west coast is 3 to 4 meters per year, with a maximum of 11 m a year. The long shore transport and thus the erosion at the western coast of Jutland is mainly wave-induced. About 100 year ago, the dunes were stabilized by marram grass planting. At the same time, harbours and groin groups were built which resulted in serious downdrift erosion. The combined result of the stabilization of the dunes and the erosion was that in 1982, the dunes has disappeared or were weak along 50 km of the coast. The leeside erosion is man-induced. In Figure 4, the locations are shown where, due to the occurred erosion, the safety level was critical in 1982.

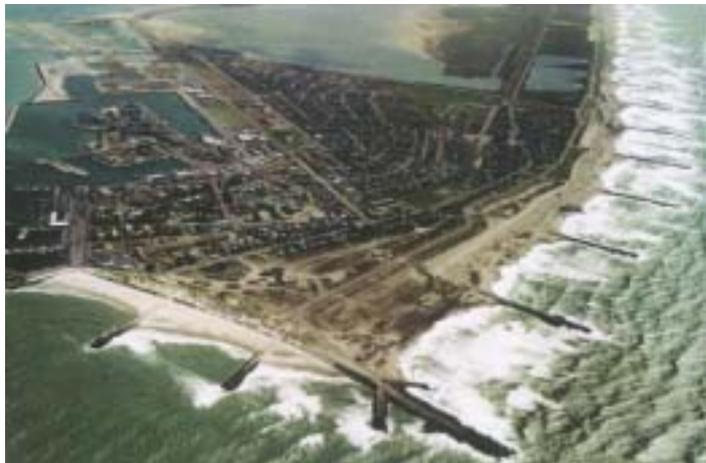
Fig. 5: Thyborøn channel entrance.

Thyborøn channel is located on the West coast of Jutland, Denmark. The channel was formed naturally during a severe storm in 1862 when waves broke through the coastal sand dunes and the narrow barrier beaches, which separated the North Sea from the Limfjord. In the years after the opening of the channel, the neighbouring coasts experienced substantial erosion, which threatened the town of Thyborøn.

The Danish Coastal Authority (DCA) has followed the evolution of the coastal zone and the inlet closely for many years. Massive protection works, groins and dikes, have been constructed, and over the past 10 years the structures have been supplemented by comprehensive nourishment of the beaches.

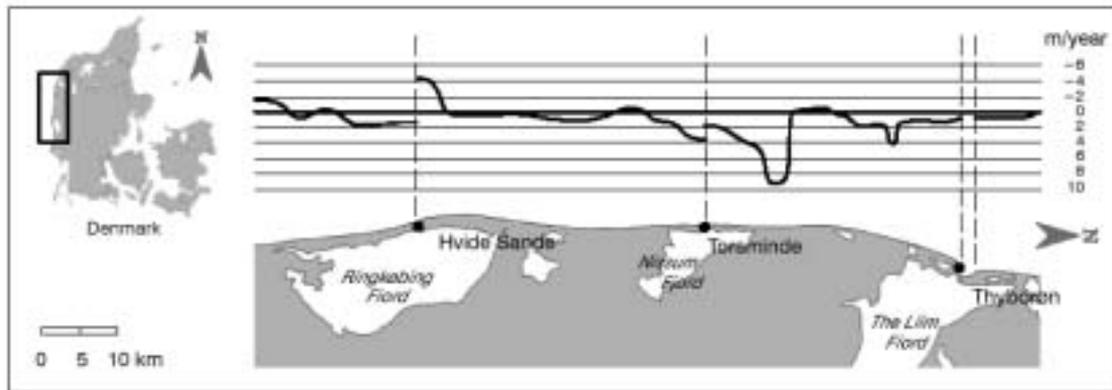
Fig. 6: Yearly erosion rates at western coast of Jutland in 1982.

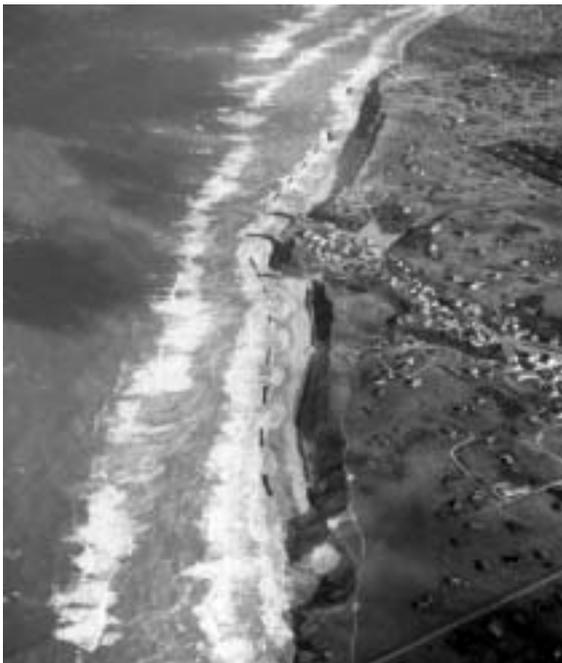
Fig. 7: Nourishment, revetment and breakwaters.

To re-establish the safety against flooding to a 100-year return period, the dunes were reinforced and new dunes were built (soft measures). However, in many cases it was not possible to reach the safety level required because there was not enough land between the beach and the houses or the road to build a sufficient dune volume. In this case, hard measures were taken in the form of revetments.

- On highly exposed stretches where erosion should be stopped, low detached breakwaters were used in combination with nourishment. One reason for the use of breakwaters was that for historical reasons, local politicians trusted in hard structures like groins and breakwaters. Another reason was the high price of the nourishment sand.

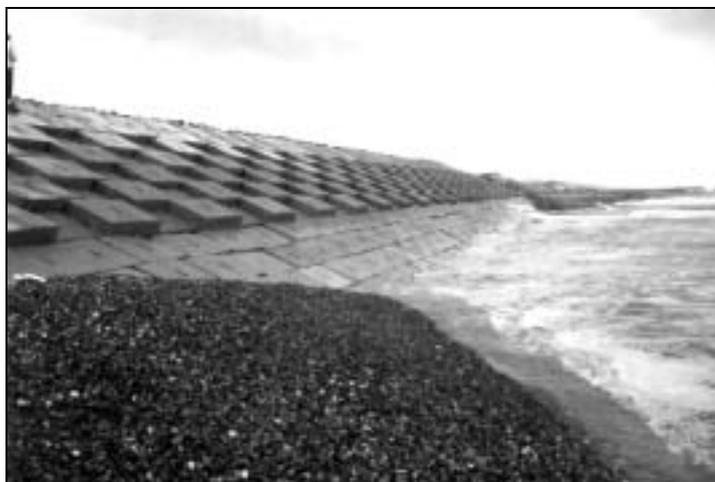
Fig. 8: Revetment at western coast of Jutland.

In cases where it was not possible to reach the safety level required with nourishments, because there was not enough land between the beach and the houses or the road to build a sufficient dune volume, revetments were applied.

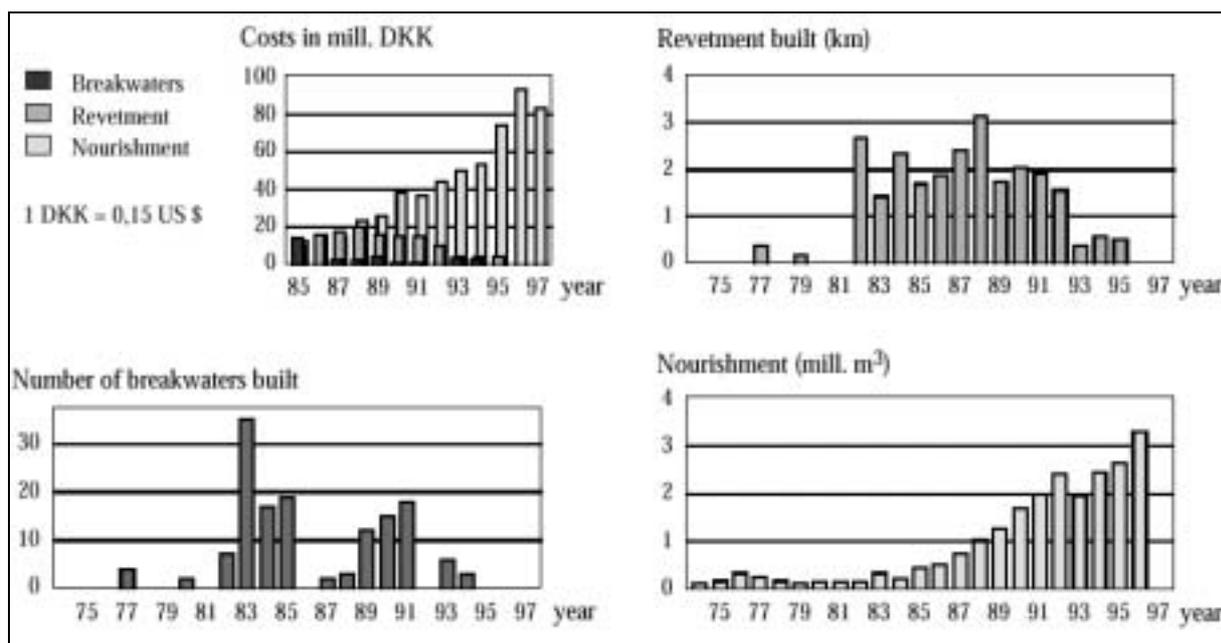
Fig. 9: Development of construction types and costs in time.

Figure 6 shows the development in the use of structures and beach nourishment for the period, including costs. For the revetment the number of kilometers is shown, for the detached breakwaters the number of breakwaters built are shown and for the nourishment the volume (Mm^3) of sediment is shown.

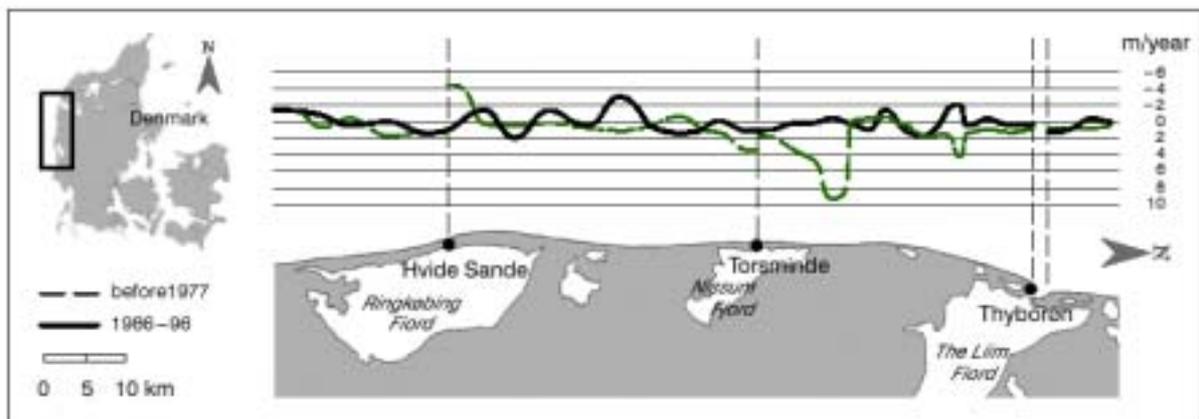
Fig. 10: Effect of coastal protection scheme on erosion.

Figure 10 shows the coastline retreat rate in 1998 for the southern part of the North Sea coast. The very high erosion rates are no longer a fact. We do not have absolute zero erosion but the erosion has been stopped where it is important for the dune safety and on average, the coastal erosion rate is 0.1 m/year. The safety level of the dunes has been reestablished to a level of at least 100 years, which was the goal in 1982.

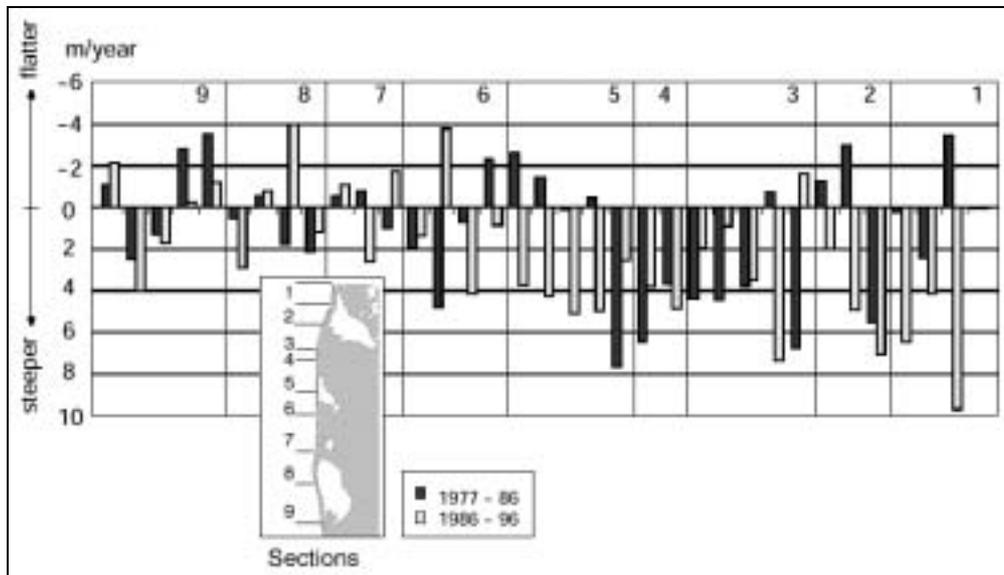
Fig. 11: Difference between retreat rates seaward and landward of -6 m.

The retreat rates shown in Figure 7 have been calculated for the profile section from -6 to +4 m. For nourishment we only use a volume equivalent to the erosion on this part of the profile. As it could be expected, this policy leads to a steepening of the profiles. Figure 8 shows a number of bars each representing a number of profiles on a part of the coast. The length of the bars represents the difference between erosion velocity of the profile seaward of -6 m and landward of -6 m. This difference represents the steepening of the profiles. Before 1986, the steepening took place on parts of the coast where groin groups had been built (sections 3,4 and 5 in Figure 8). After 1986, the steepening mainly took place where the nourishment projects were carried out (sections 1-5 in Figure 11).

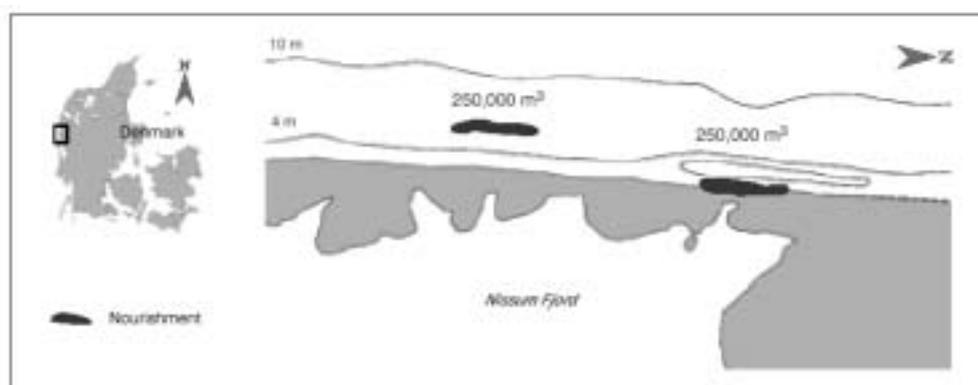
Fig. 12: The nourishment location plan at Nissum Fjord.

In 1993 - 1996, the European Union MAST project Nourtec was carried out with participation from the Netherlands, Germany and Denmark. In the Danish case, a nourishment project on the long shore bar and a project on the beach were studied (Lastrup and Madsen, 1996).

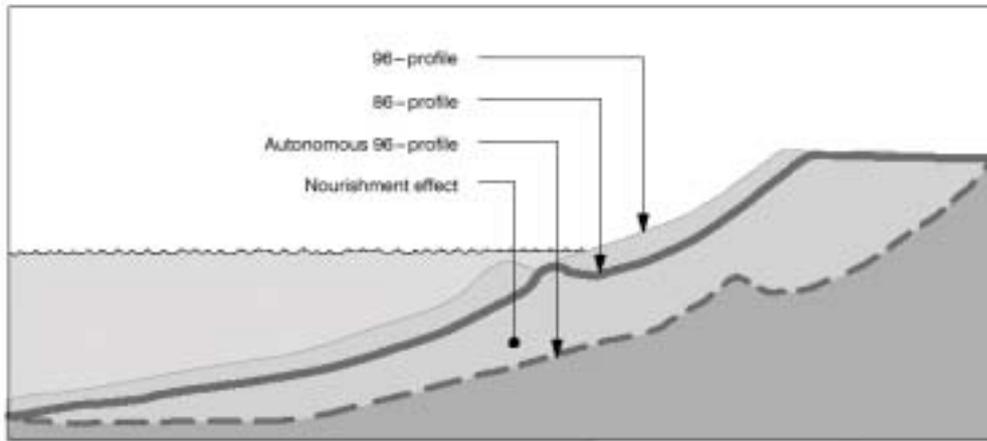
Fig. 14: Effectiveness of a nourishment.
