MARINA DI RAVENNA LIDO ADRIANO (ITALY)

1. GENERAL DESCRIPTION OF THE AREA

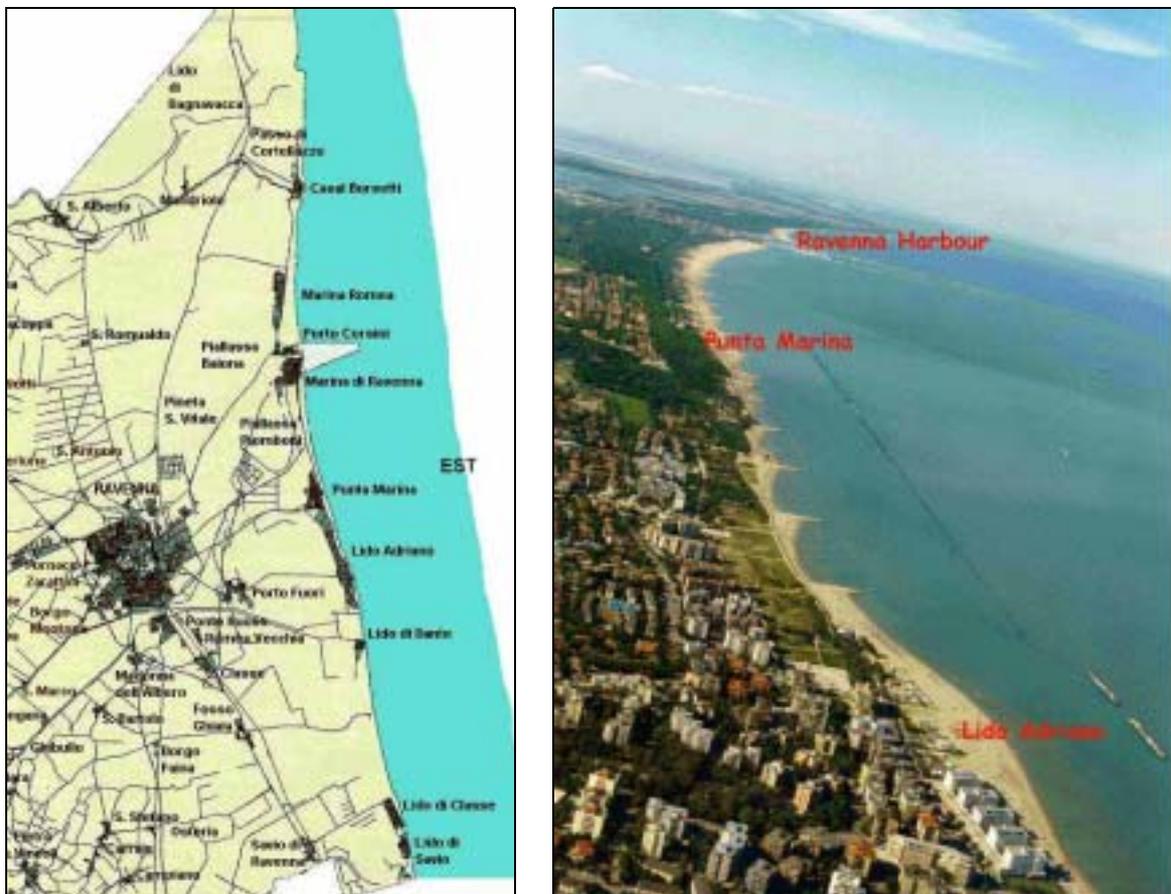
Fig. 1: Studied area (Marina di Ravenna- Lido Adriano area/ Ravenna's coast).

The area considered in this report (about 10.5 km long) corresponds to the coastal area of Ravenna between the Fiumi Uniti river mouth and the southern jetty of the Ravenna Port (Fig.1). During the last century, the entire coastline has been strongly influenced by two main factors:

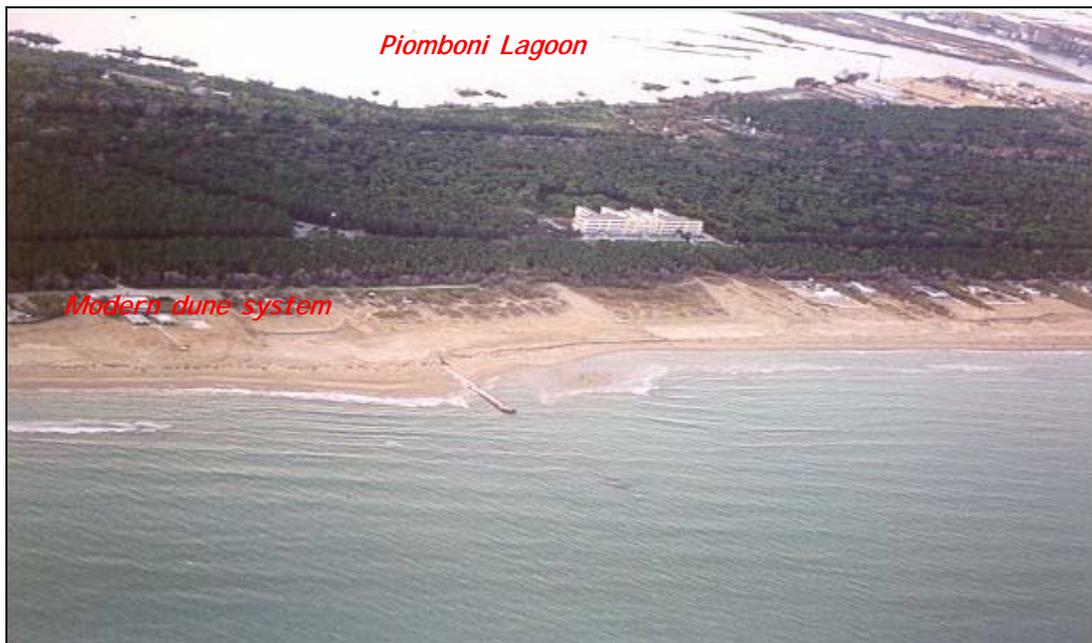
Fig. 2: Details of the beach - dune bars - lagoon system in the area. The pinewood has been artificially planted on ancient dune bars.

The examined area is formed by the interaction between river-delta and marine coastal processes. From the late Holocene until the beginning of the '900, the coastline has undergone a progressive accretion. This trend was possible through the development of a system of breakerbars which acts as a natural boundary for the marshlands and the backwater areas (Fig.2).

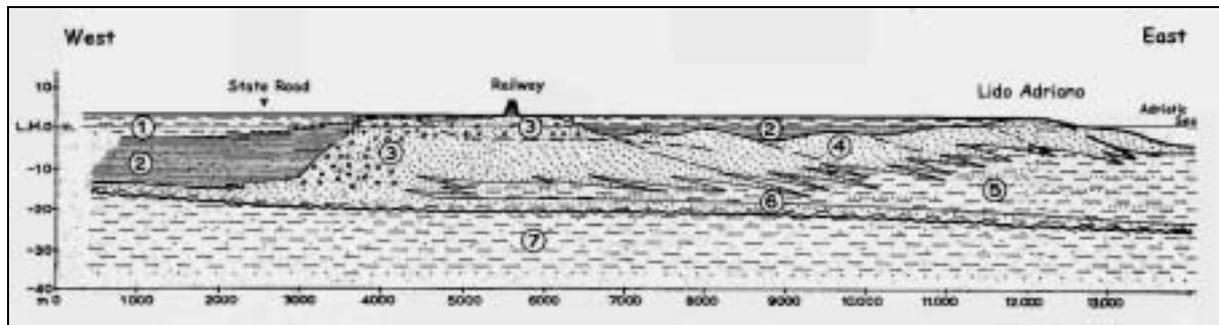
Fig. 3: Schematic stratigraphic section across Marina di Ravenna- Lido Adriano area. Legend: (1) yellow clay of modern land reclamation; (2) clay with peat, sandy and clayey mud of lagoon environment (3) Sands and beach gravel; (4) Beach and marine coastal environment sands; (5) Mud with sandy levels of marine coastal environment; (6) Sands and mud of Holocene transgression; (7) Clays, mud and sands of continental environment (Angeli et al., 1970; modified.).

Detailed stratigraphical information available for the area (Emilia Romagna Region, 1999) shows that the coast is characterized by sand-beaches covering muddy-clayey materials derived from more ancient swampy and alluvial deposits (Fig. 3). Generally, the thickness of the modern sands does not exceed 4-6 m. This sediment, displaying a classic cuneiform geometry, completely disappear at a water depth of about 4-6 m. Type of surface sediments: approximately fine sands (an average of Mz 2.06 ϕ in the shoreline; 3.43 ϕ at 2.5 m depth)

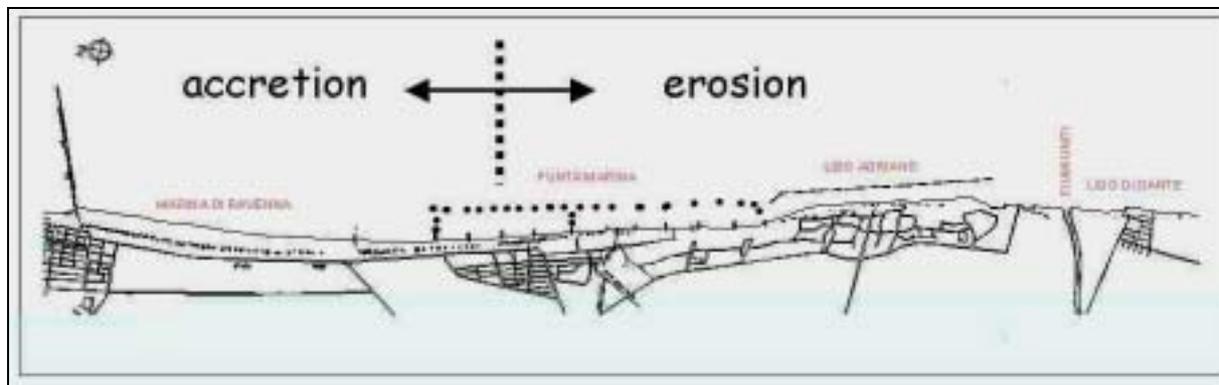
Fig. 4: Littoral area between the Fiumi Uniti river mouth and the southern jetty with a schematic map of the erosion-accretion zones

In the last decades, as a result of the combined effects of subsidence, jetty construction, urbanisation, lack of sediment supply from rivers, etc., the coastline experienced a huge erosion rate in the southern part (from the Fiumi Uniti river mouth to about Punta Marina) and a significant accretion in the northern part (close to the jetty; Fig. 4).

After an extreme storm event, which occurred in 1966, the majority of the Northern Adriatic coastal areas was flooded. Since then, many coastal protection structures have been built along the coastline. Protection structures can be found offshore Lido Adriano (Fig. 4), with a serie of detached breakwaters and a seawall (in the late sixties), offshore Punta Marina with a serie of rock groynes and a beach nourishment (in the late eighties) protected by a submerged breakwater and submerged groynes all of them made with sand bags.

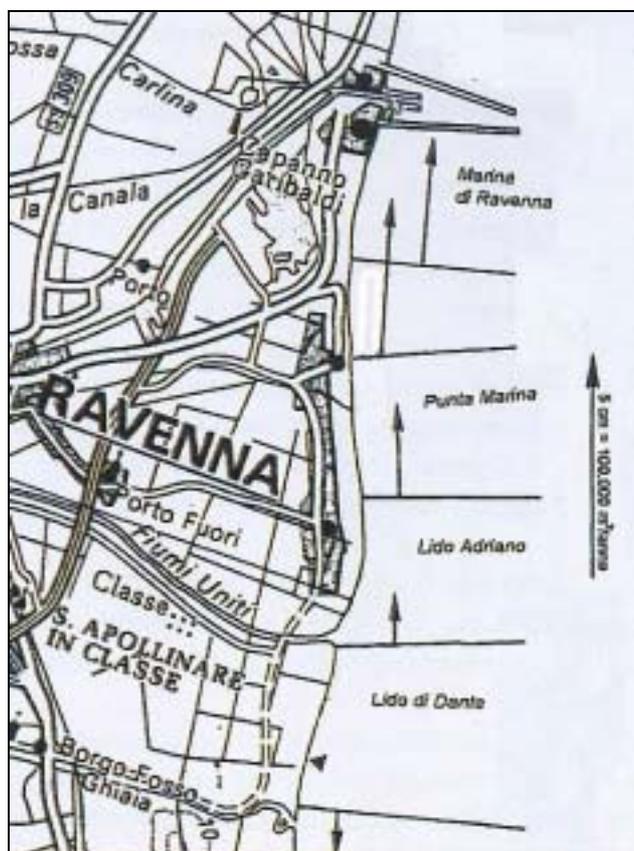
Fig. 5: A schematic map of the main direction of the total solid transport recorded in the area (Idroser, 1996).

The prevailing wind and waves, which determine the main components of the solid coastal transport in the area (Fig. 5) are those from the North-east (locally called "Bora") and the South-east ("Scirocco").

More detailed analyses of the distribution of total solid transport perpendicular to the coastline show that for different intensities, frequencies and waves steepness, the prevailing sea are from the SE (influenced by Sirocco wind) close to the shoreline, and from the NE (influenced by Bora wind) where water depth is higher than 3 m.

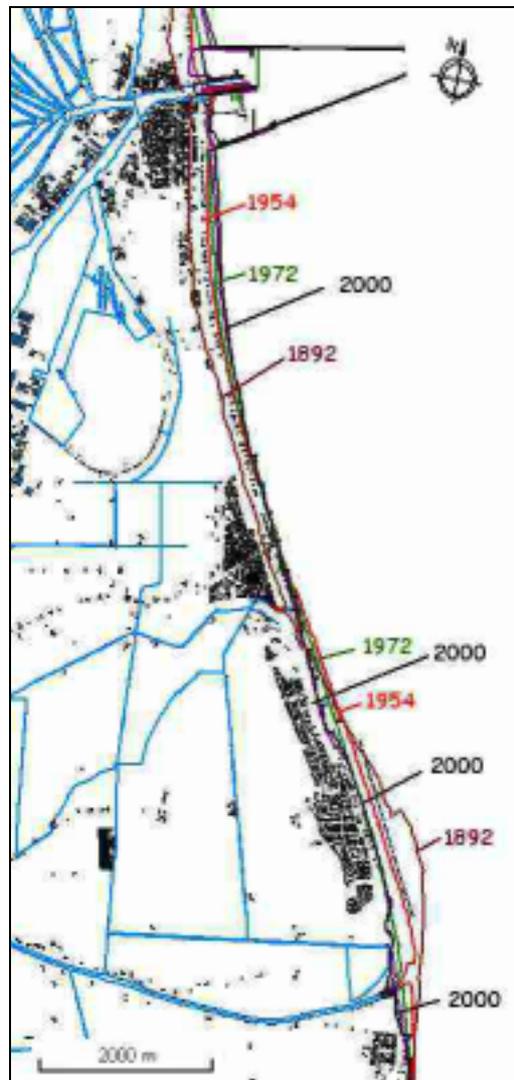
Fig. 6: A schematic map of the modern coastline evolution of the area.

The shoreline shows erosion and accretion in different places. These erosion and sedimentation patterns change over time. The development of the coastline, based on the analysis of available aerial imagery taken from 1954 to 2000 is schematised in Fig. 6. Bottom altimetric evolutions, obtained by 1968-2000 bathymetric surveys, are summarised in Fig. 7-8.

Figure 6, 7 and 8 show both erosion and sedimentation in the area. The main erosive phenomena are recorded in the zones surrounding the Fiumi Uniti mouth, which has been dismantled and withdrawn of about 450 m in the last century mainly because of the decreased fluvial solid contributions (consequent negative total sediment budget). During this century the entire region has suffered from the modifications of the human activity, which has almost completely destroyed the original environmental setting.

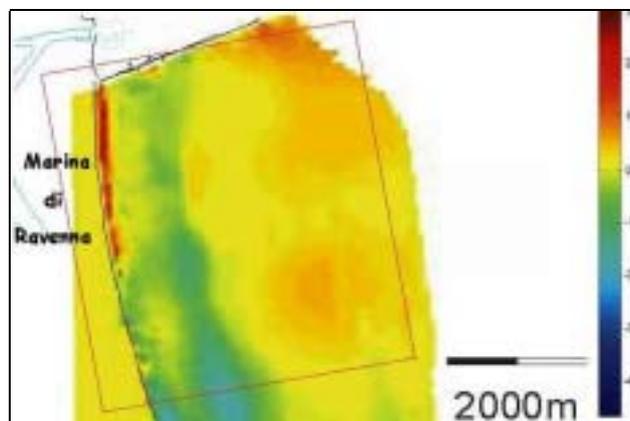
Fig. 7: Schematic map of altimetric variation (m) of the seafloor from 1968 to 2000 in the Marina di Ravenna zone.

In Marina di Ravenna the emerged beach shows a marked accretion (about 140-150 m in the last 50 years) while, where water depth exceeds 3-4m, a slight negative altimetric budget can be observed. It was caused by a loss of about 1.7 million m³ of sediment, in the period between 1968 and 2000 (Fig. 7).

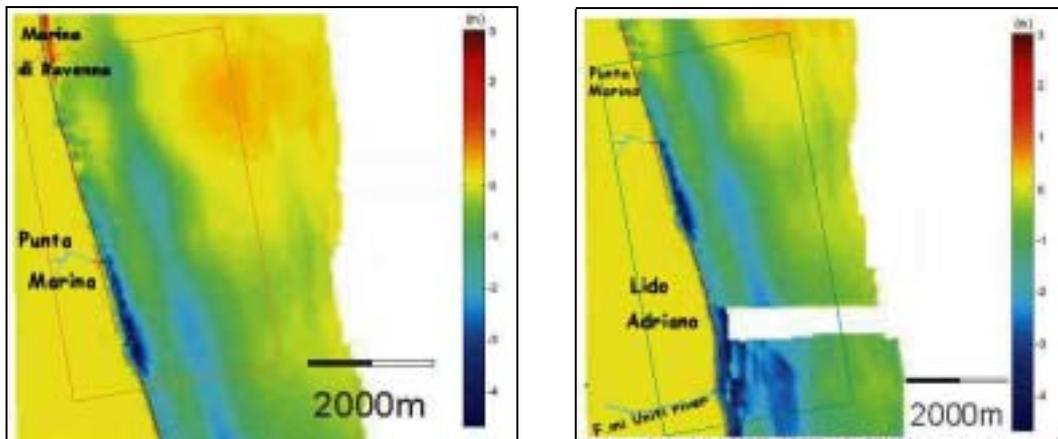
Fig. 8a & 8b: Schematic altimetric variation (m) of the seafloor from 1968 to 2000 in the Marina di Ravenna zone (on the right) and Lido Adriano- Foce F.mi Uniti (on the left).

Obviously, during the same period, higher volumetric values have been recorded in Punta Marina and Lido Adriano where erosion takes place. In this areas the loss of sediment ranges from about 13 million m³ between Punta Marina and Lido Adriano (Fig. 8a) to more than 27,5 million m³ in the area between Lido Adriano and the Fiumi Uniti river mouth (Fig. 8b).

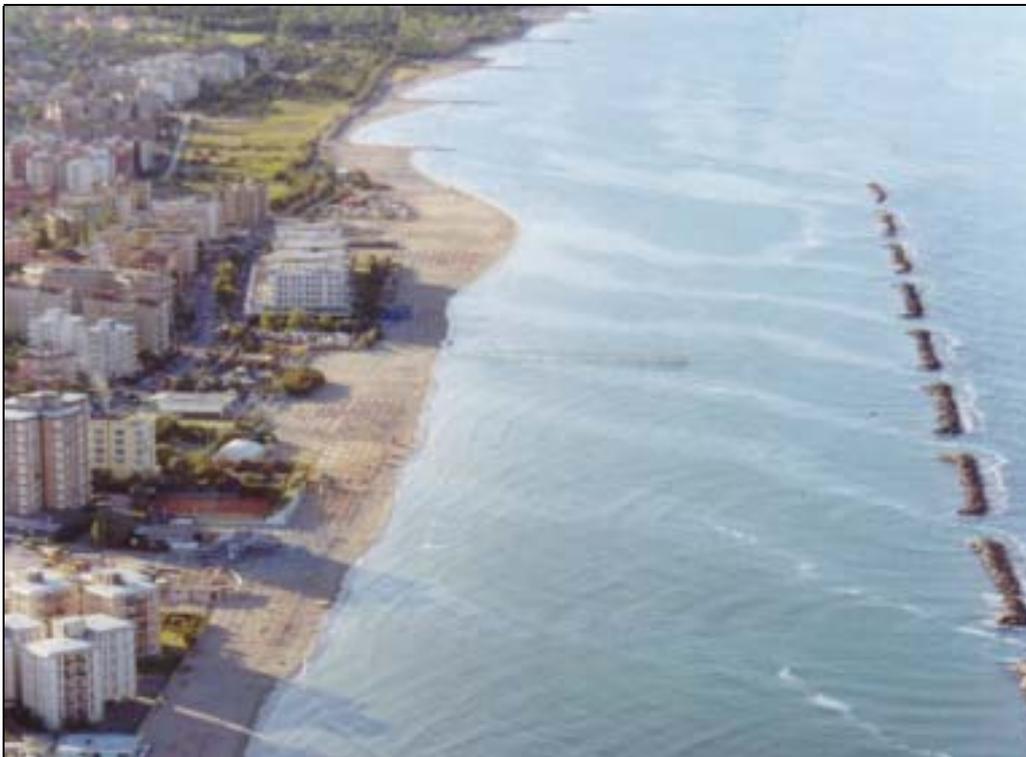
Fig. 9: Clear example of uncontrolled coastal urbanisation in Lido Adriano area.

In addition, in the last 30-40 years, an intensively increased anthropic activity, mainly connected to the development of tourism, has led to a complete alteration of the coastal morphology (for example, substantial dismantling of the sand bars and urbanisation in proximity of the beach; Fig. 9) and of the coastal dynamics with an associate increasing subsidence.

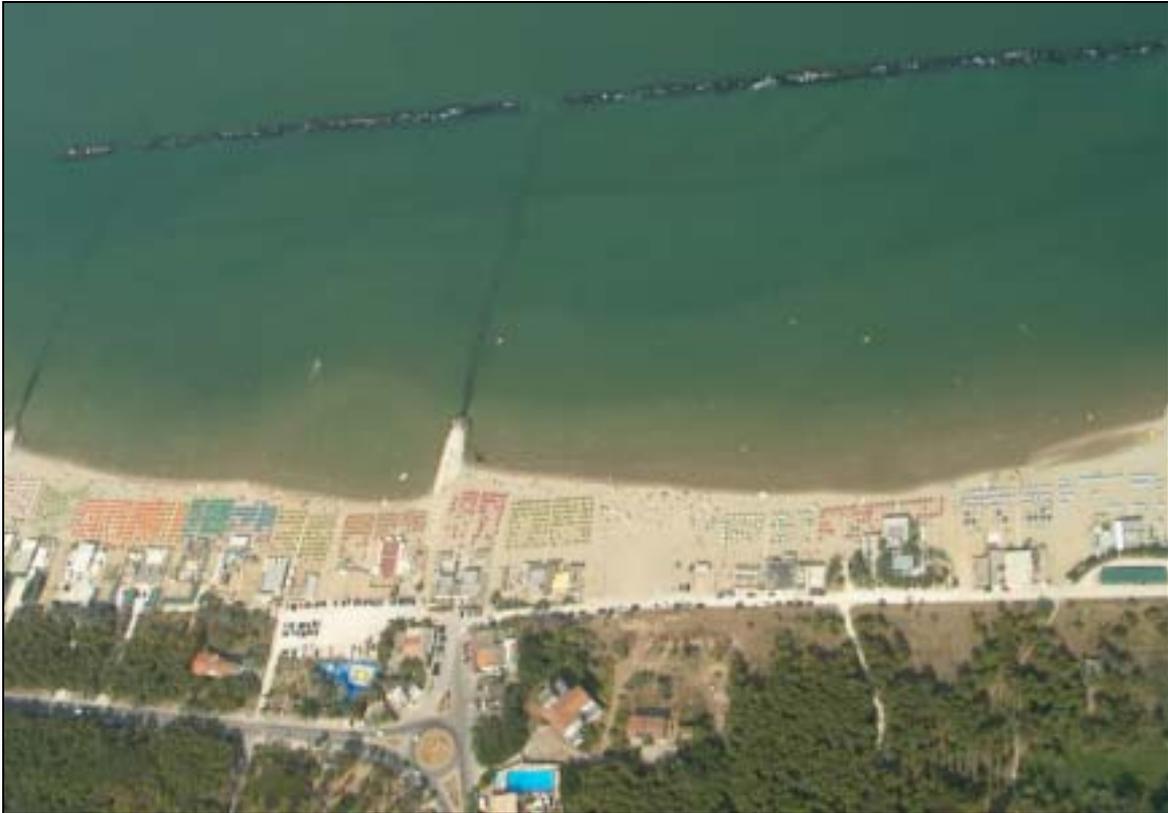
Fig. 10: Example of bathhouse built in Punta Marina impacting the residual dune bars and pinewood.

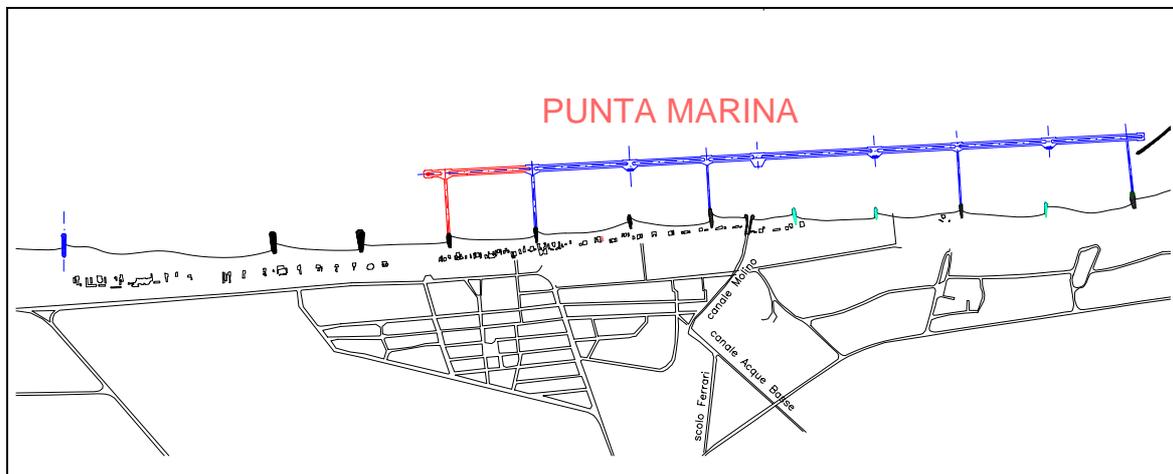
Fig. 11: Coastal area of Punta Marina with existing coastal protection structures (in blue 1999-2000 protection structures, in red breakwater prolongation).

The actual beach management strategy, according to the present knowledge, began in 1997, with the design of a new coastal semi- submerged protection structures (Fig. 11, 12), required because the previous submerged breakwater and groynes made of sand bags resulted ineffective. The former works, in fact, did not give any kind of protection to the beach, which kept eroding very quickly.

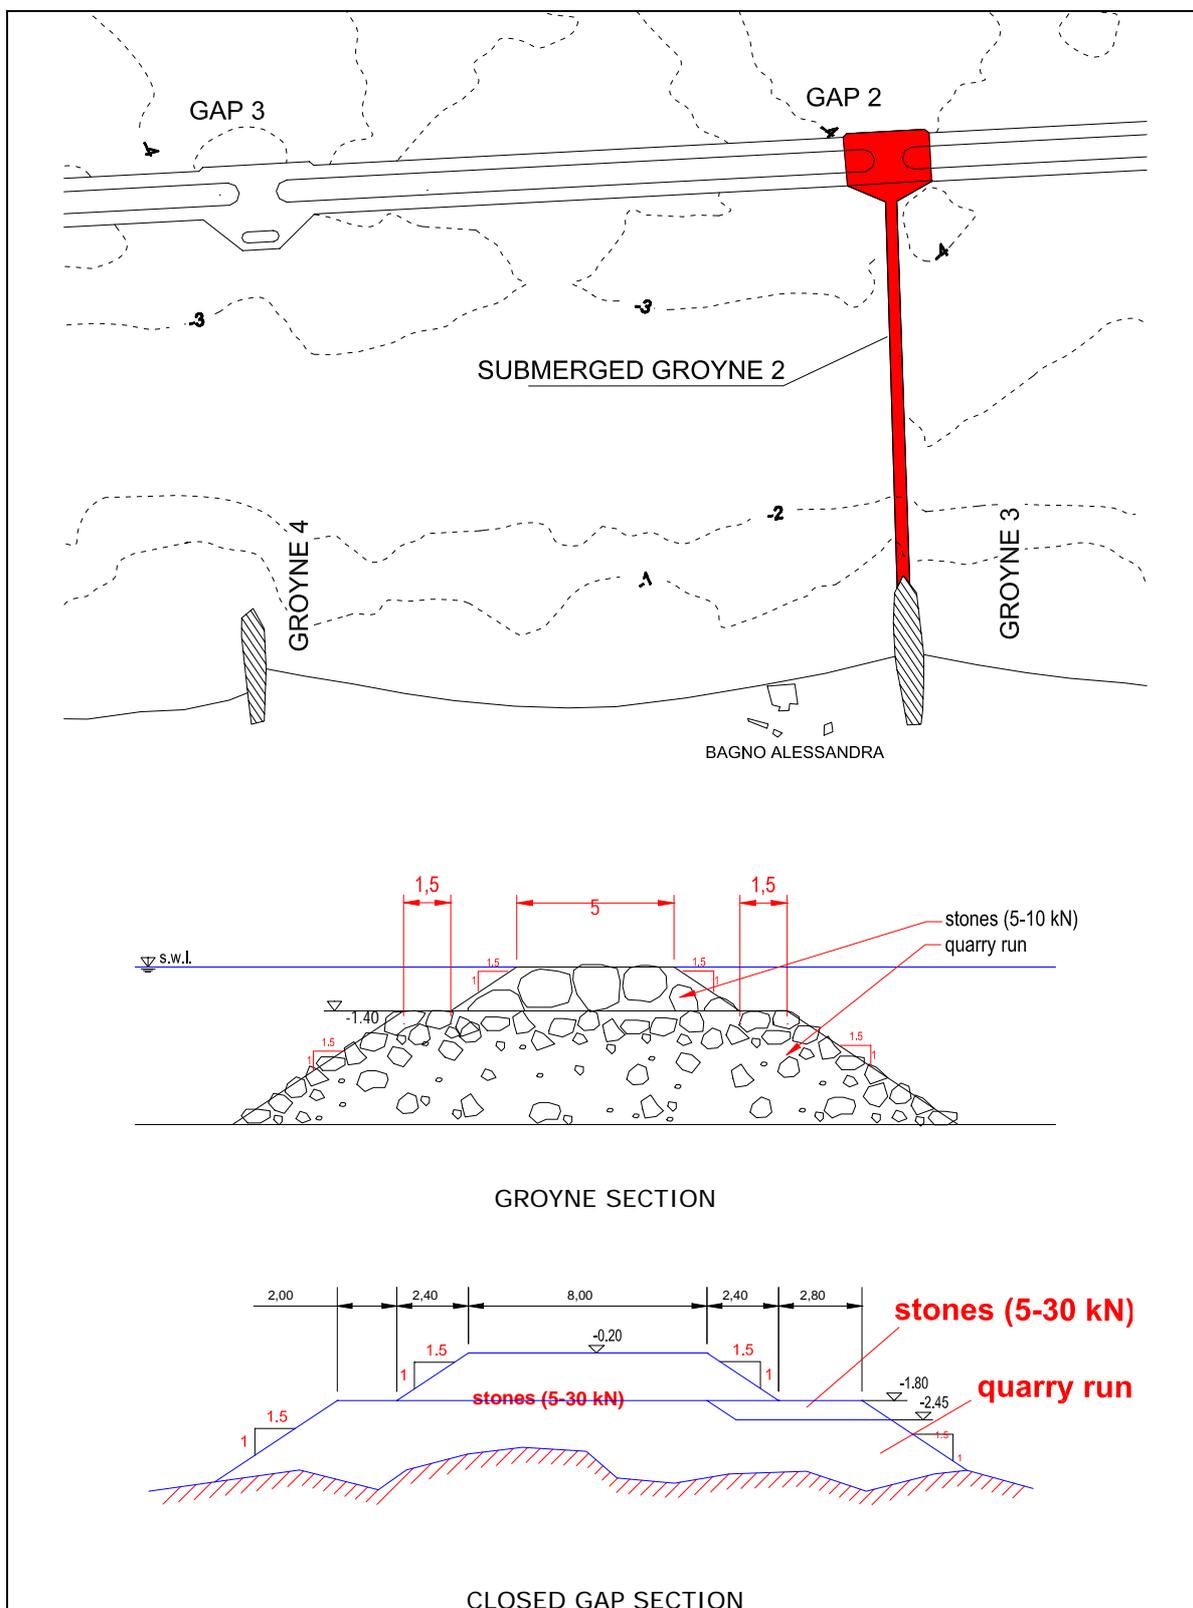
Fig. 12: Designed maintenance and improvement of new semi- submerged structures in front of Punta Marina.
