## VALE DO LOBO (PORTUGAL)

## 1. GENERAL DESCRIPTION OF THE AREA

The aim of the project “Artificial Sand Nourishment of Vale do Lobo beach – Algarve 97” was to stabilize the coastal stretch of Vale do Lobo that has been showing pronounced and in some cases irreversible coastal erosion (INAG, 1997).

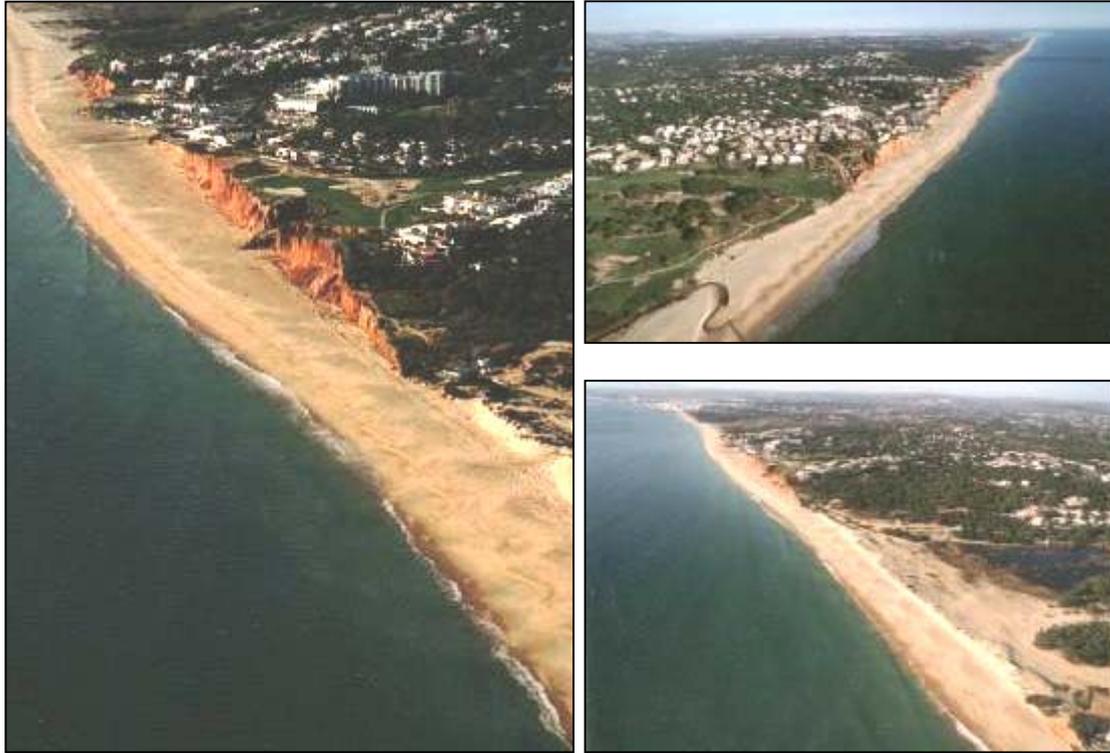
*Fig. 2: Vale do Lobo beach.*

Vale do Lobo beach is a high and cliffed beach of about 5 km length, as seen in Figure 2.

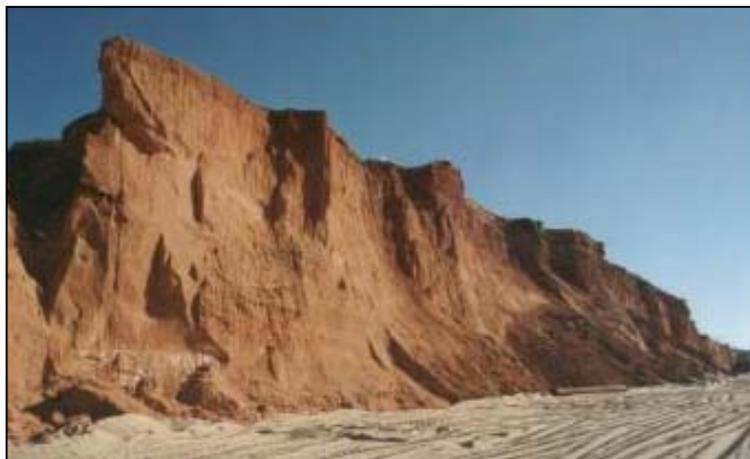
*Fig. 3: Red sand cliffs.*

The cliffs of Vale do Lobo beach are almost vertical formations of red sands of the plio-plistoceno, Figure 3.

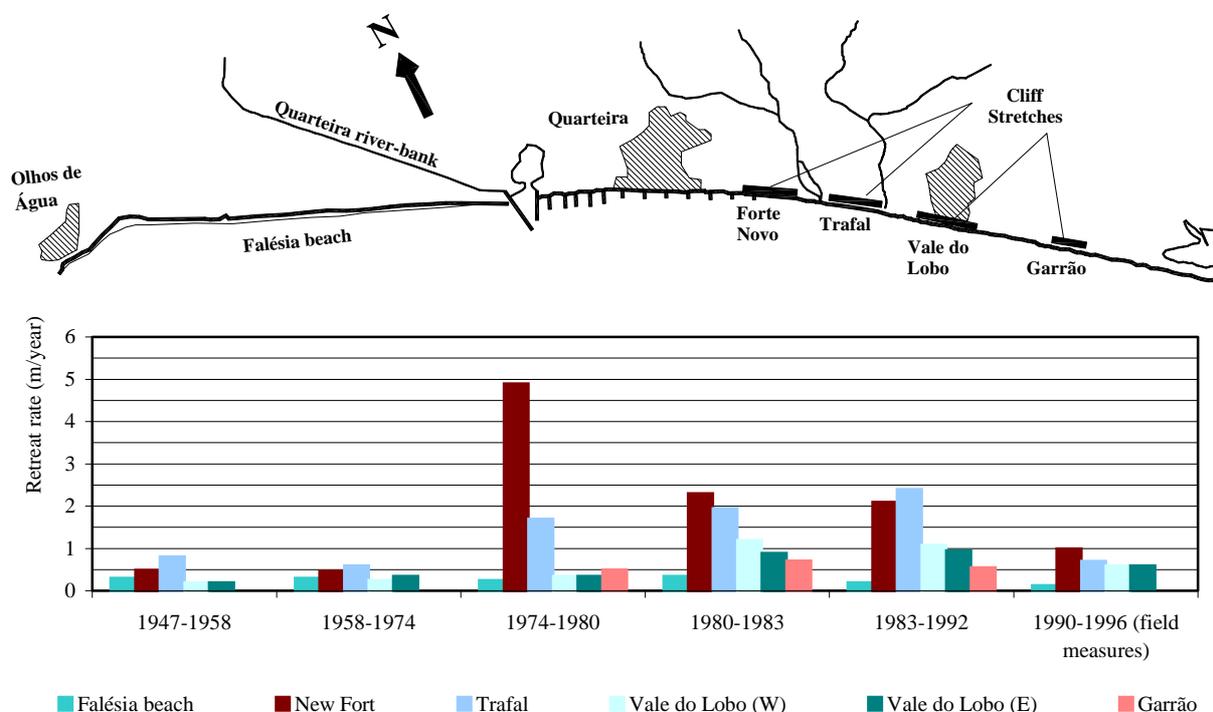
Fig. 4: Retreat rates of the cliffs of the Quarteira Region (adapt. Marques, 1997).

As it can be observed in Figure 4 this erosion have reached Vale do Lobo beach between 1980 and 1983 after the retreat of approximately 30 m between 1976 and 1980 at the New Fort cliff, updrift Vale do Lobo. This erosion have threatened the Vale do Lobo Resort and motivated the construction of coastal defences between 1983/84.

After the intense erosion period of the seventies the retreat rates have diminished to values around 0.6-0.7 m/year (between 1990 and 1996), these values are slightly higher than the ones registered in the fifties and sixties before the construction of the sea works. This fact suggests that the littoral system has reached a situation near the equilibrium, after two decades of changes in depth (Marques, 1997).

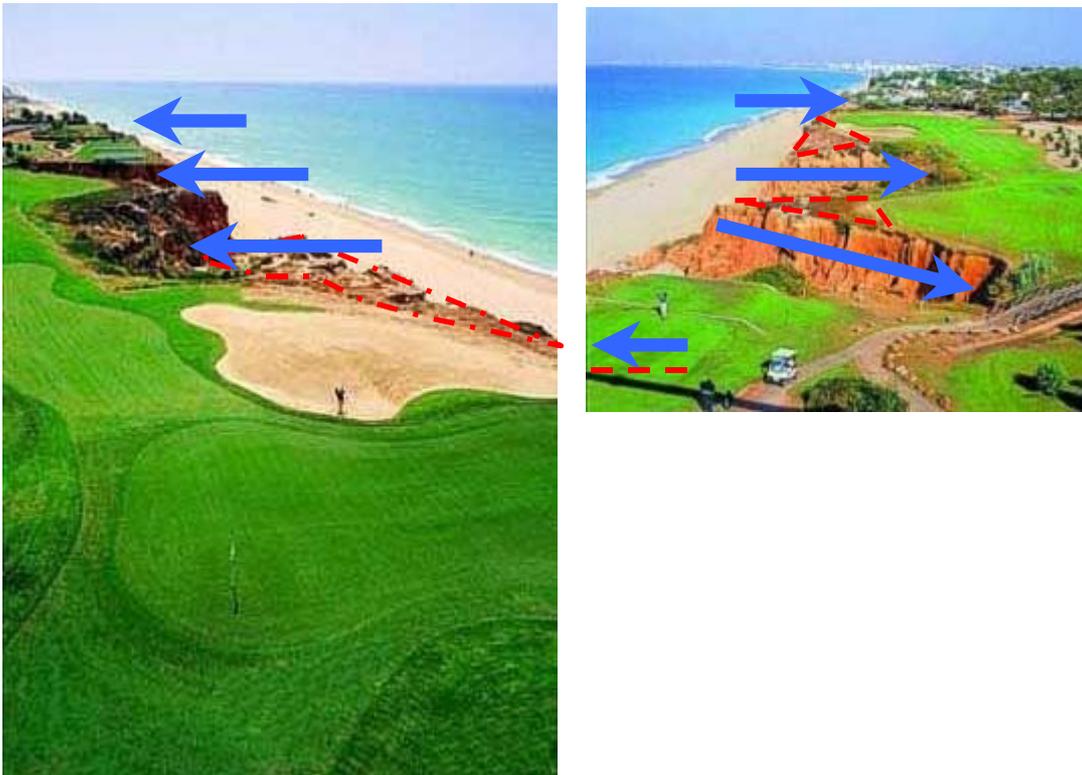
*Fig. 7: Examples of eroded areas along Vale do Lobo beach.*

The erosion happening in Vale do Lobo is mainly a direct consequence of human activities. The cliff has been retreating further and further threatening people and buildings, Figure 7.

The mentioned retreat mainly results of:

- The beach narrowing due to the updrift interception of the littoral sand transport in Quarteira marine and subsequent defence structures.
- The rill and gully erosion after heavy storm episodes.
- Golf course and gardens watering.
- And it can be easily observed all along the shoreline.

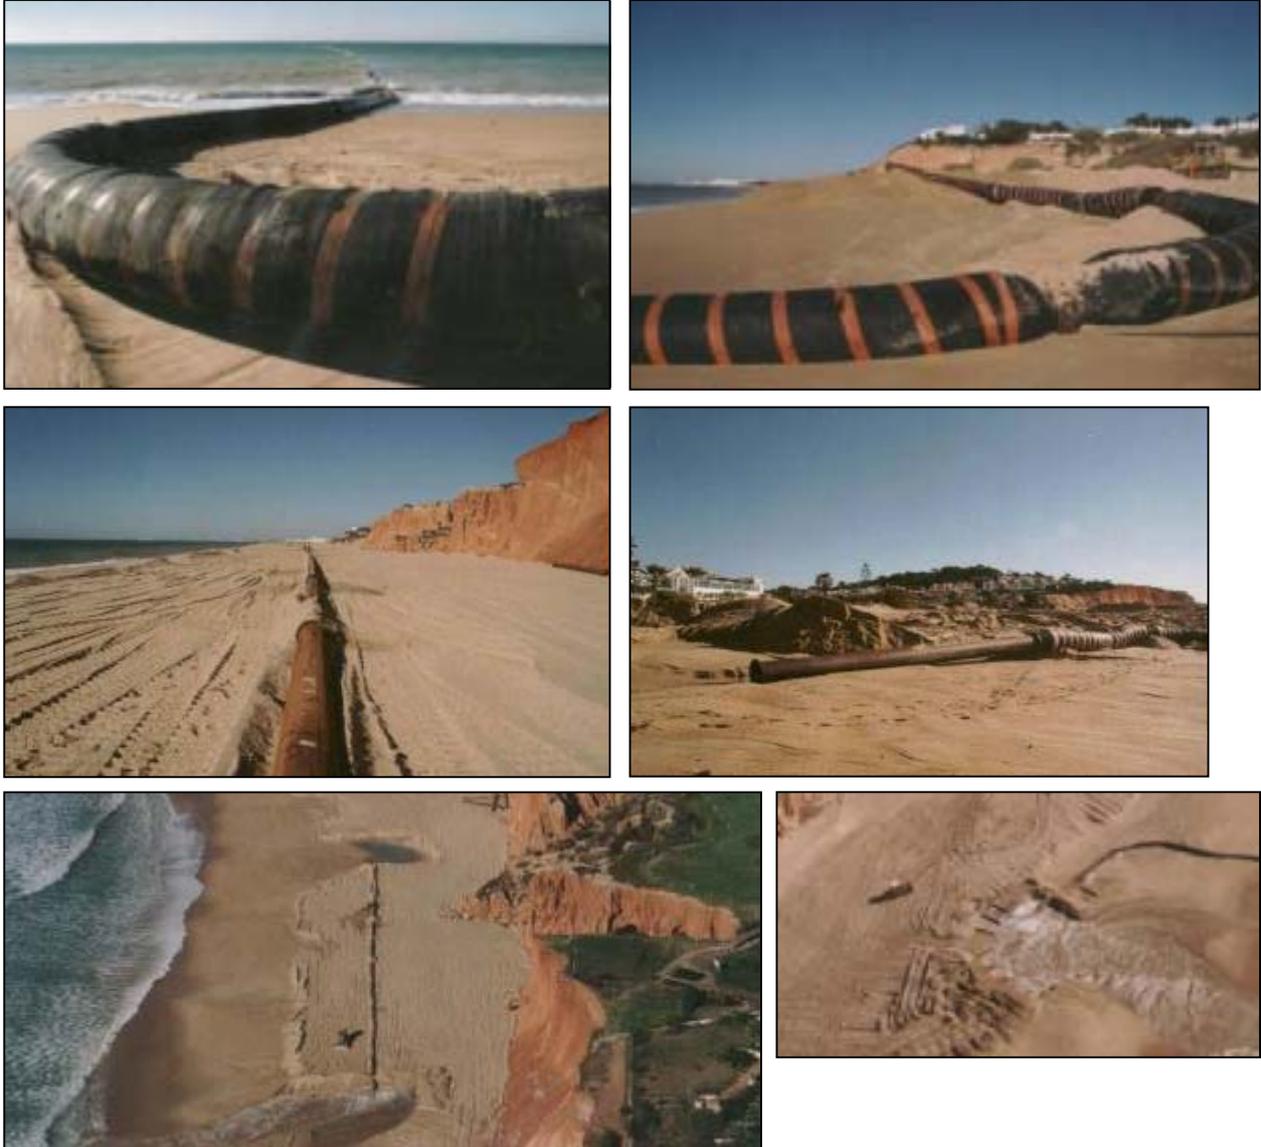
*Fig. 8: Floating pipe.*

This operation consisted of the dredging of the  $700.000 \text{ m}^3$  on the shoreline band frontal to the beach and its repulsion to the beach through a floating pipe so that the designed beach platform could be created, Figure 8. The dredging area was located at the approximately distance of 4 km from the beach and approximately 20 m depth. The dredging equipment was a trailing suction hopper dredger, Figure 9.

According to INAG, 1997, the main goal of the programmed intervention was to create a “new” beach on Vale do Lobo, 2 or 3 m above the existent level in a extension of 1400 m and a beach width growth of approximately 80 m. The sand needed ( $\sim 700.000 \text{ m}^3$ ) for this operation was obtained by offshore dredging in a predefined zone.

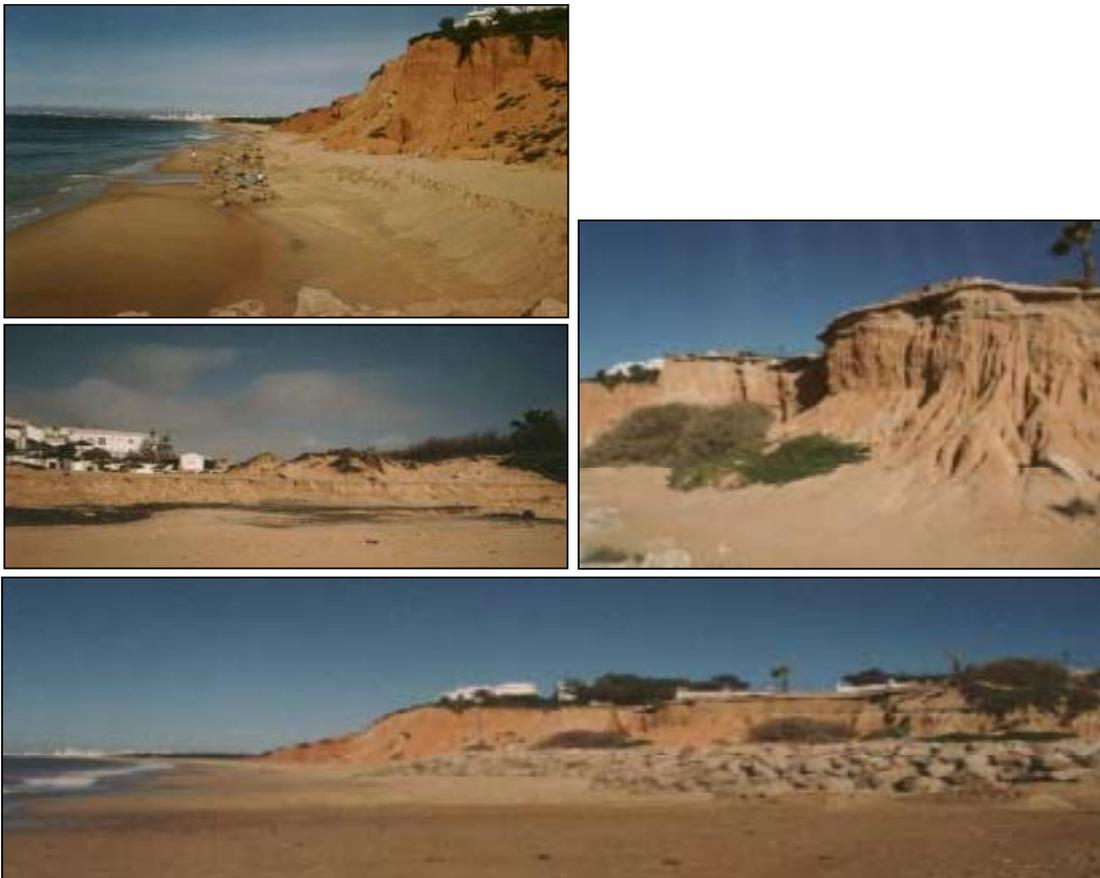
*Fig. 11: Vale do Lobo beach situation before the artificial sand nourishment operation.*

Figures 11 to 13 show a sequence of pictures of Vale do Lobo beach before, during and after the operation of artificial sand nourishment.

In effect, as proven short time after the nourishment operation in 1999, the high erosive strength of the sea has taken in great part the sand volume placed artificially on the beach. This way, it is expected that, due to the severe wave climate, the need for new reloads will be frequent thus increasing the costs with low efficiency warrant.
