MAMAIA (ROMANIA)

1. GENERAL DESCRIPTION OF THE AREA

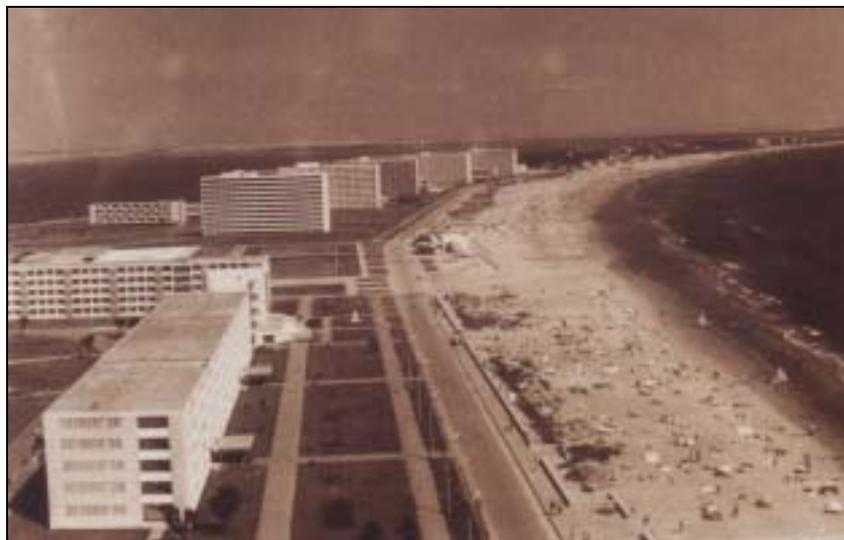
Fig. 7a: The southern part of Mamaia Beach in 1961 before the Midia harbour construction.

After the extension of the Midia harbour dike, Mamaia beach recorded accretion in the northern part and erosion in the south. In winter 1988, the southern part of the beach was severely destroyed by erosion. Beach shoreline retreated up to 59 m, among 1966 and 1988 and the beach surface eroded was 88900 sq m (see photo 4). Urgent protection measures that consisted of 6 longshore breakwaters and artificial nourishment were designed. After the implementation of the coastal protection scheme, shoreline retreat continued with rates up to 35 m and limited accumulation with maximum value of 15 m between 1978 – 1995.

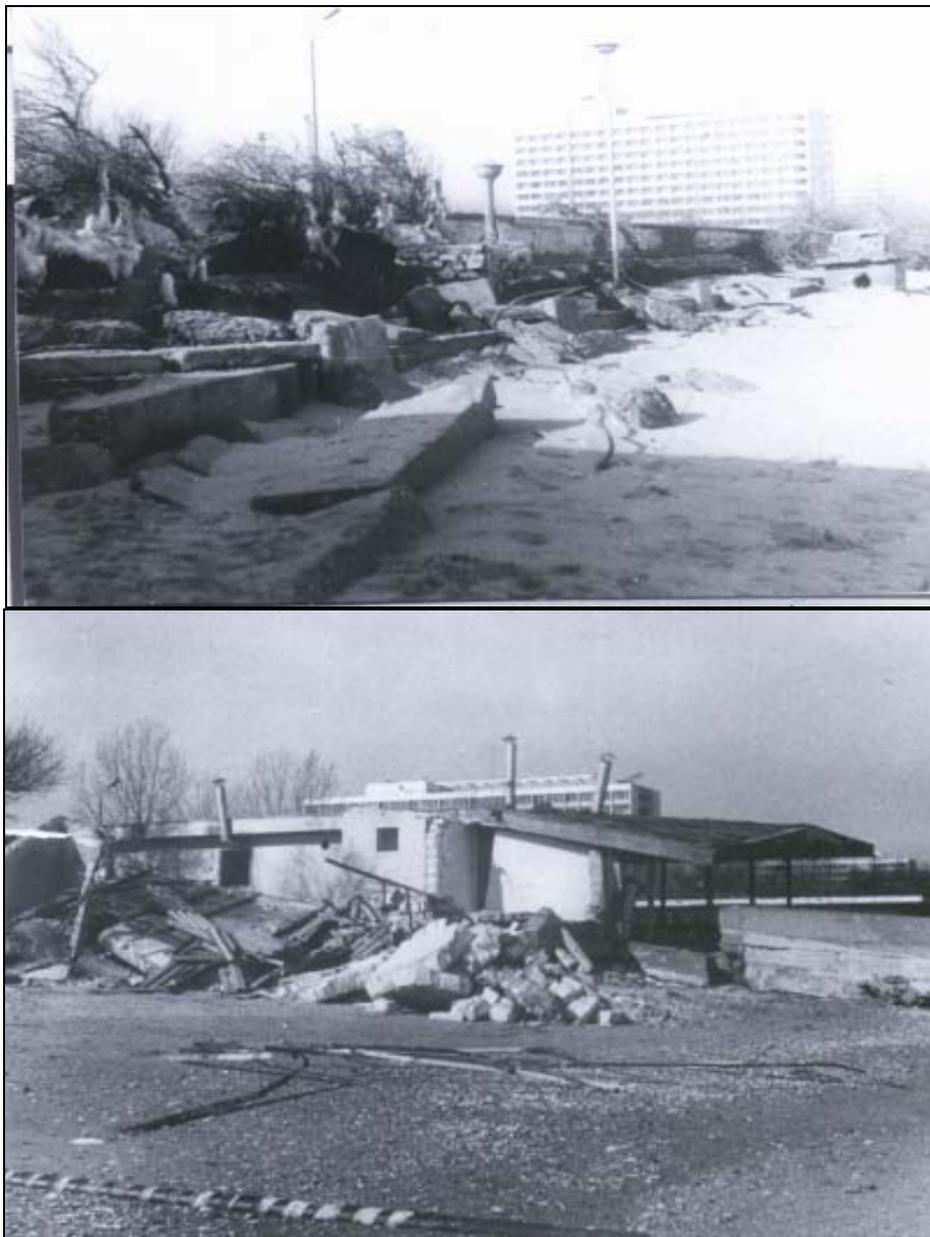
Fig. 8: Storms impact on the beach 1988.

Severe storms in 1981, 1986 and 1988 have aggravated the erosion process, particularly in the southern part of Mamaia beach. Over the period 1966 –1988 the shoreline retreated with 59 m and 88,900m² beach surface has vanished. Simultaneously with erosion, degradation has been reported under the form of biological changes and declining biodiversity. Significant damages have occurred to beach developments and some hotels have been endangered.

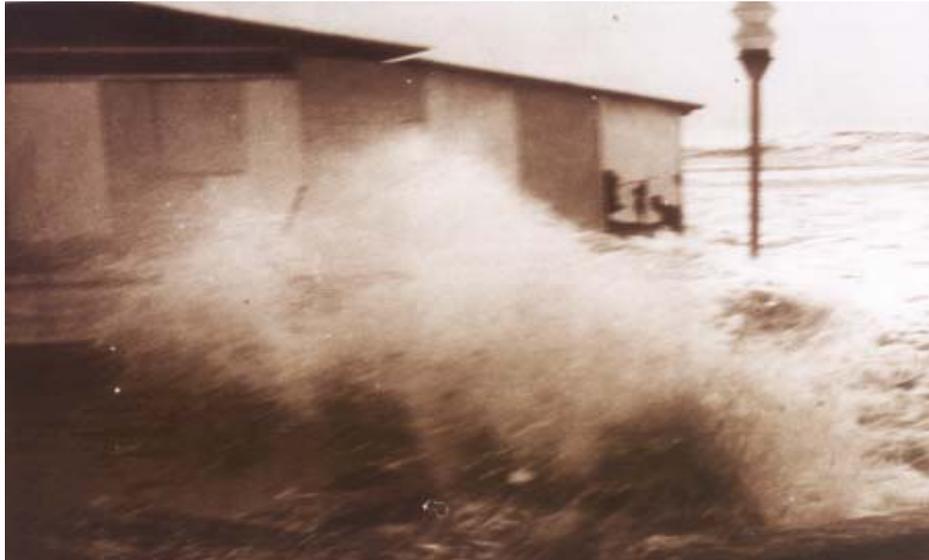
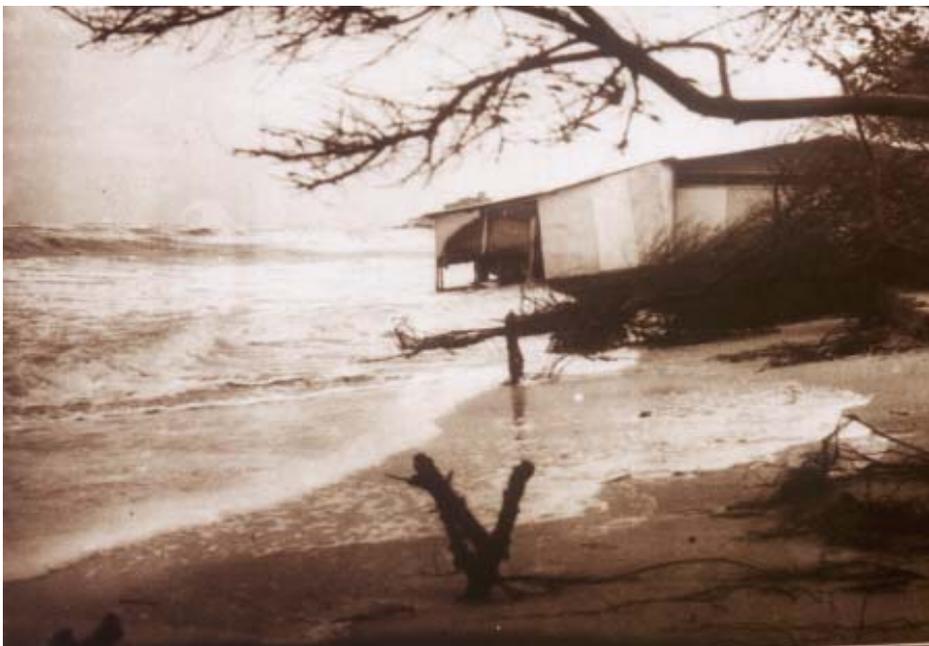
Fig. 9: Storm damages on Mamaia beach 1986.

In the winter season the combined action of hydrodynamic and aerodynamics forces results in high waves which remove a large quantity of sand from the beach and destroy the beach facilities.

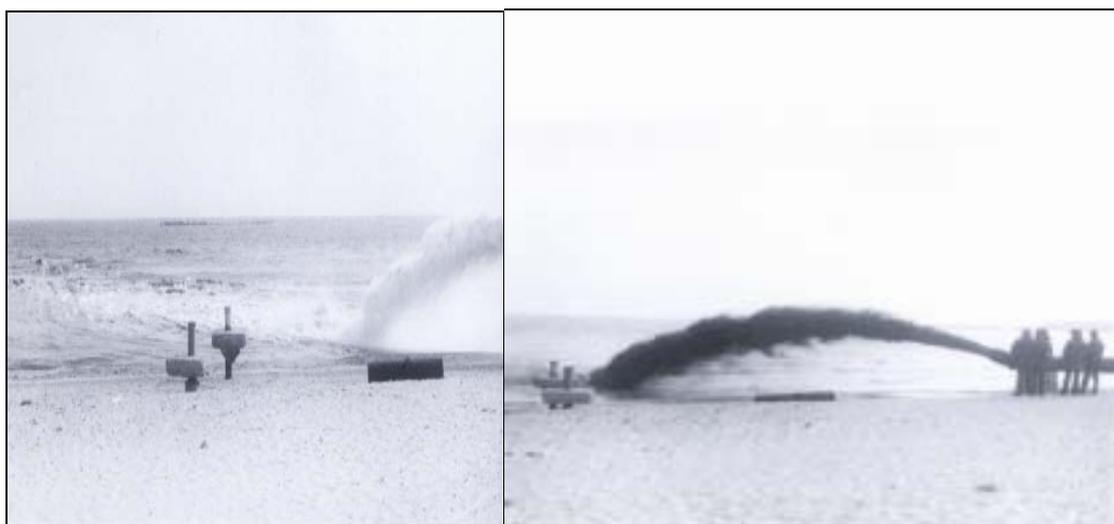
Fig. 11: Pumping sand from Siutghiol Lake - artificial nourishment.

The nourishment works started in February 1989 and ended in June 1990. During this period the sedimentary budget increased with about 500 000 cubic meters sand. The total beach surface renewed from the beach nourishment was 64 000 m². The sandy material combined with mud was taken from the Siutghiol Lake and hydraulic pumped on the beach (see figure 11). The sediment had a fine texture and a dark grey colour that totally differed from the beach sand colour.

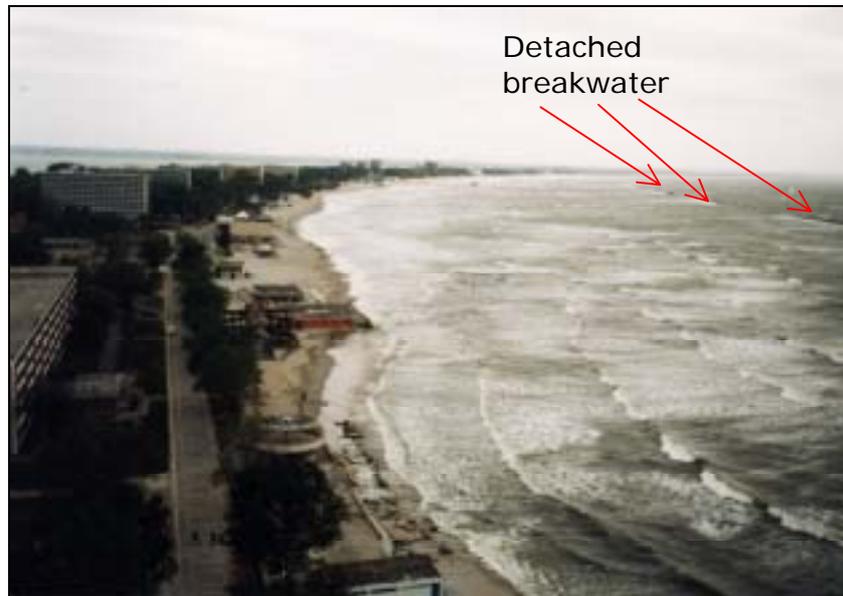
Fig. 12: Mamaia beach- the shoreline in 1998.

The artificial nourishment was stopped in 1991 because of the hydro-geologic and ecological equilibrium of the lake was endangered. The sand was washed away in short time and the erosion rate increased in the area (see figure 12).

The beach area protected by breakwaters represent about 30 % of the total length of beach cell (12.5 km). Shoreline retreat was stopped directly in front of the breakwaters for a short period of time, but erosion rates nevertheless increased in the protected area and northward of the protected area. The beach survey carried out every year indicates a very slow trend of “tombolo” formation in front of the protected beach behind the detached breakwaters. The development level of these geomorphologic forms is different from one breakwater to another.
